Prospective Home Inspections

Property Inspection Report

56 Sunshine Dr, AnyTown, IL 60538
Inspection prepared for: Happy Homebuyer
Real Estate Agent: Chris Prokopiak - Redfin

Date of Inspection: 2/20/2024 Time: 4:00 PM Size: 0
Order ID: 2113

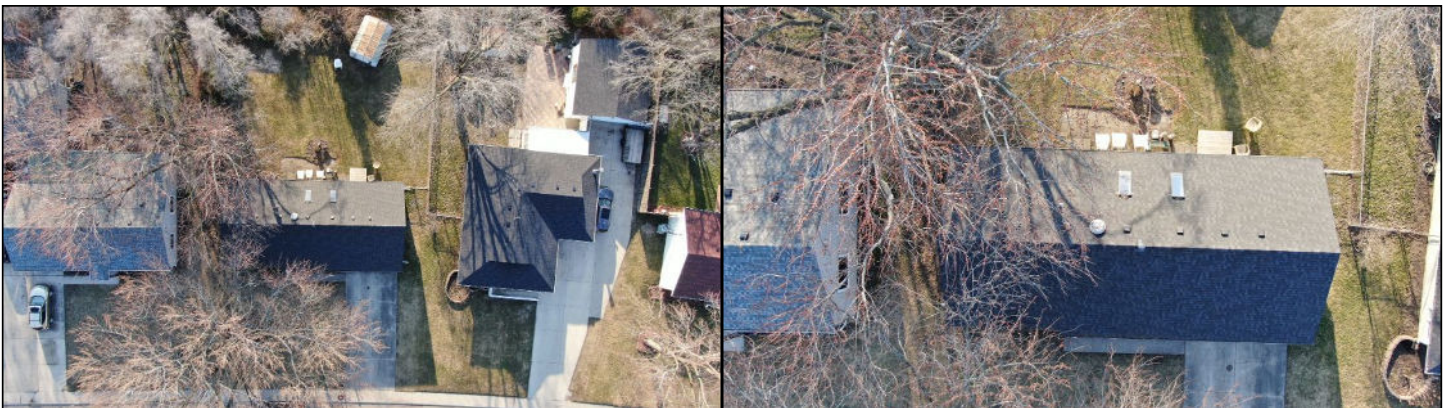
1.4. Tree branches overhanging roof. Trim trees that are in contact or proximity to home, as branches can damage roofing material.

Tree branches overhanging roof

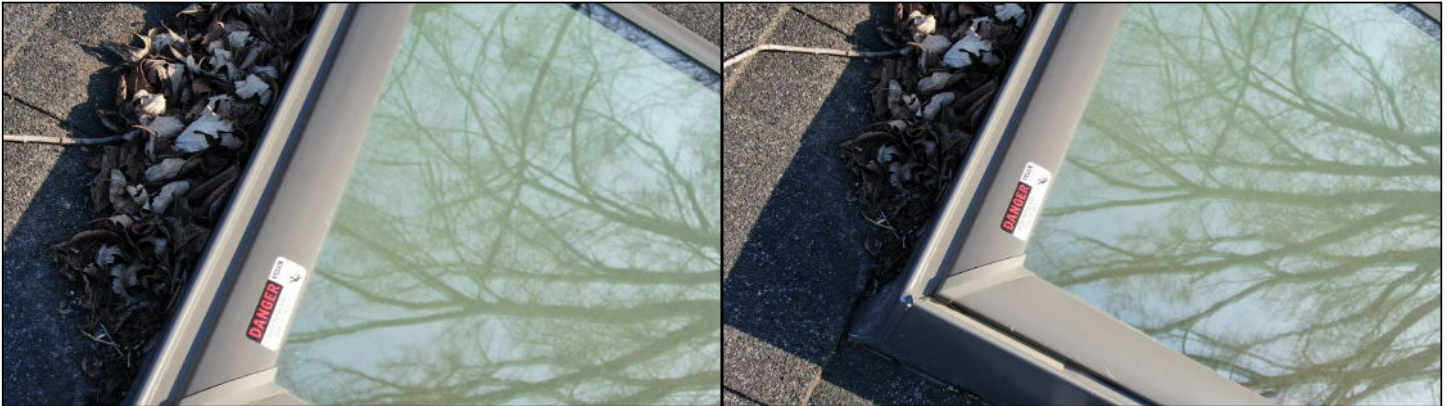
1.2. No signs of present or past leaking around the skylight were discovered at time of inspection.

No signs of present or past leaking around the skylight were discovered at time of inspection.

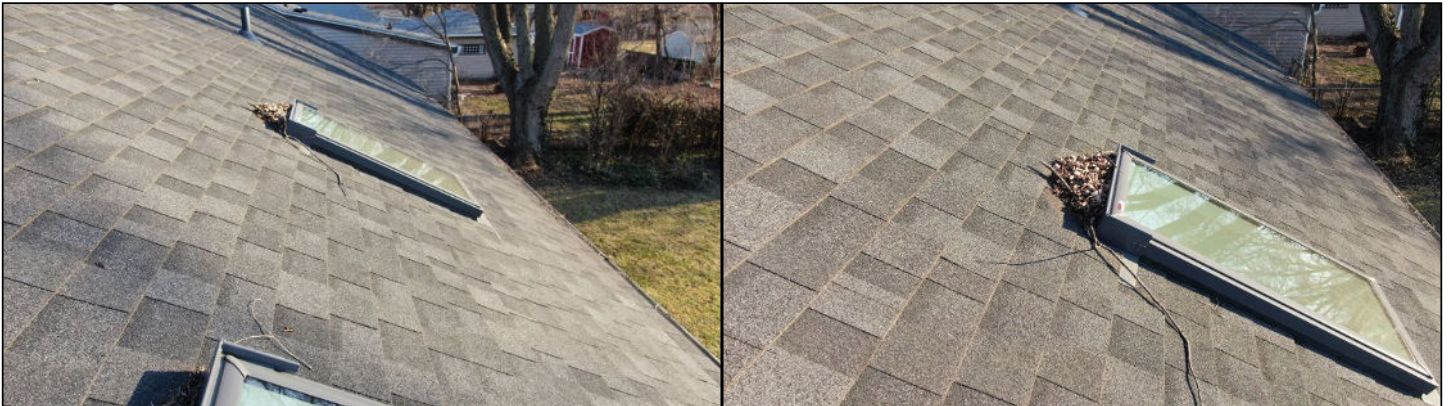
1.3. Clean roof areas: Organic debris evident. Debris on Roof surface should be removed to allow for better drainage. Additionally, debris will hold moisture which can shorten the life of the roof covering.

Clean roof areas: Organic debris evident. Debris on Roof surface should be removed to allow for better drainage. Additionally, debris will hold moisture which can shorten the life of the roof covering.

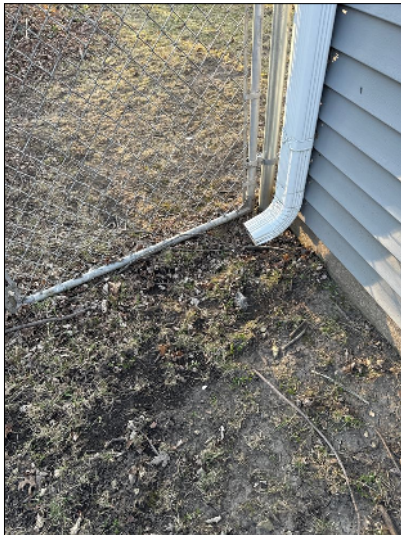
- 2.1. No major deficiencies observed; functional and in satisfactory condition, at time of inspection
- 2.2. Extensions missing - downspouts should discharge 6 feet from building and be routed to discharge away from the homes foundation, this will reduce the potential for water to seep into the basement.
- 2.3. Gutters need to be cleaned.

Extensions missing

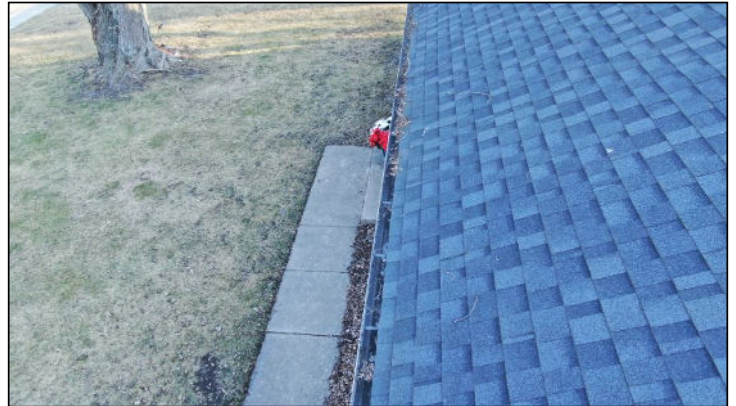
Gutters need to be cleaned.

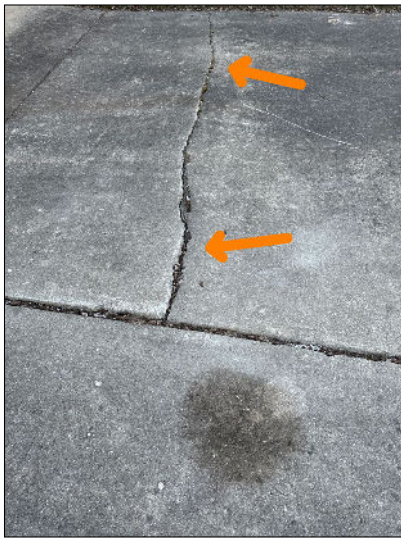
1.3. Potential Trip Hazard(s) at driveway/sidewalk; monitor / repair as necessary

Potential Trip Hazard(s) at driveway/sidewalk;
monitor / repair as necessary

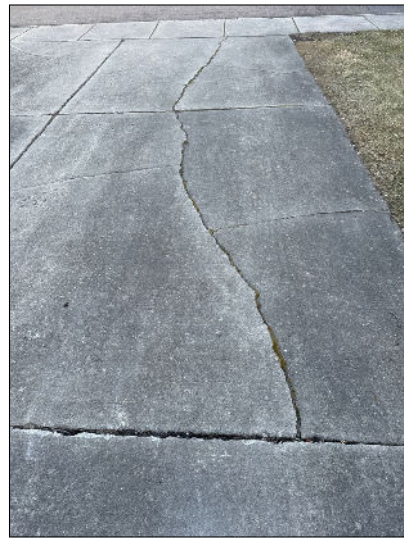
1.1. Cracks / Damage were observed. Further deterioration will occur as water expands and contracts from freeze and thaw cycles.

Cracks noted.

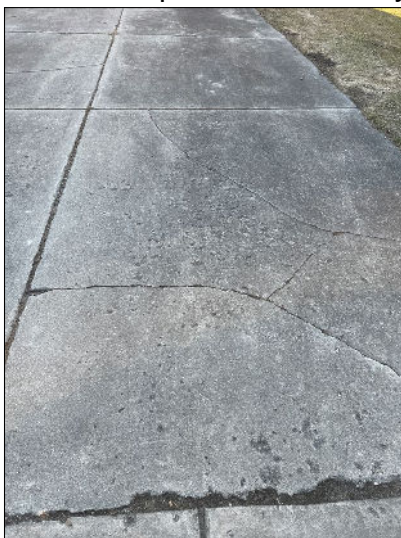
Cracks noted.

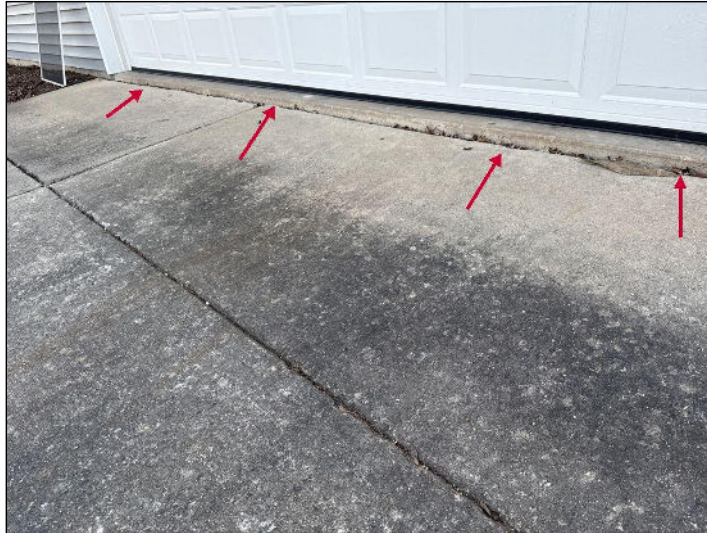
Potential Trip Hazard(s) at driveway/sidewalk; monitor / repair as necessary

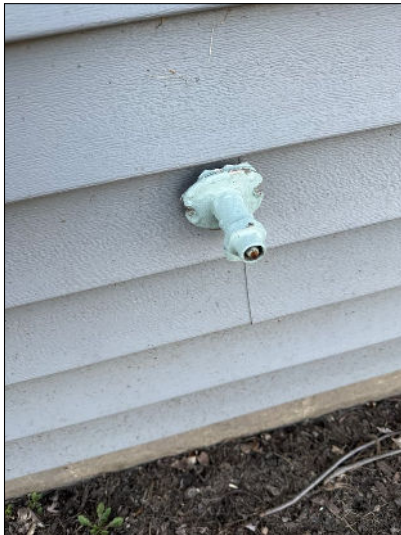
5.2. Missing / Broken handle noted at the time of the inspection on Front

Missing / Broken handle noted at the time of the inspection on Front

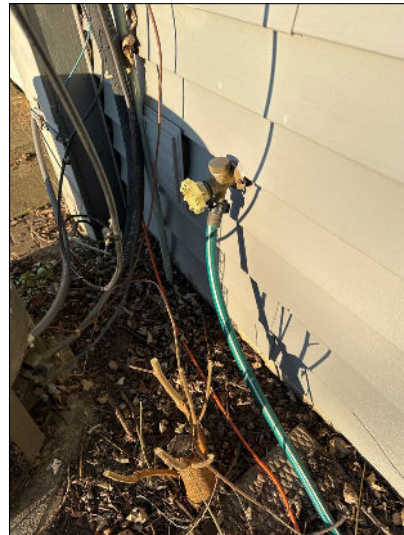
5.1. Exterior faucets have hoses attached during winter, once weather turns below 32° pipe damage may occur.

Hoses attached

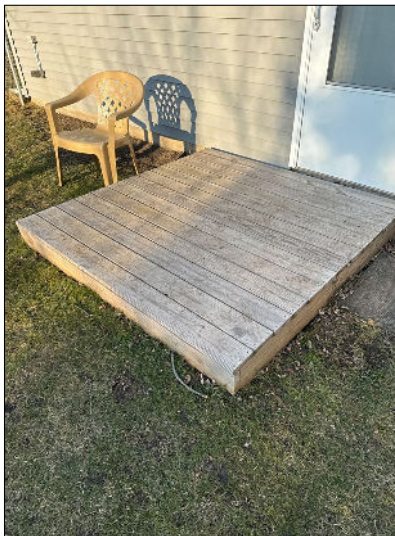
7.2. Paint or Stain is needed on the deck flooring

Paint/Stain needed

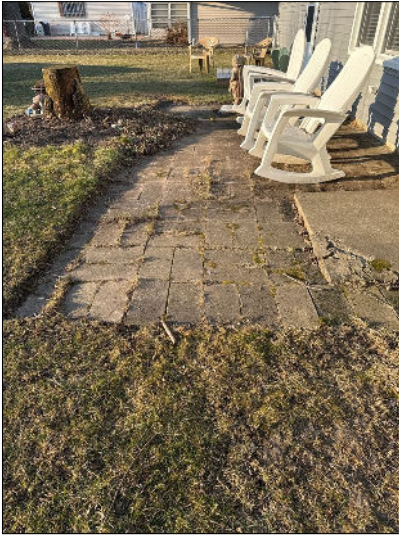
8.1. Uneven slabs/sunken/settled areas at the patio.

Uneven slabs/sunken/settled areas at the patio.

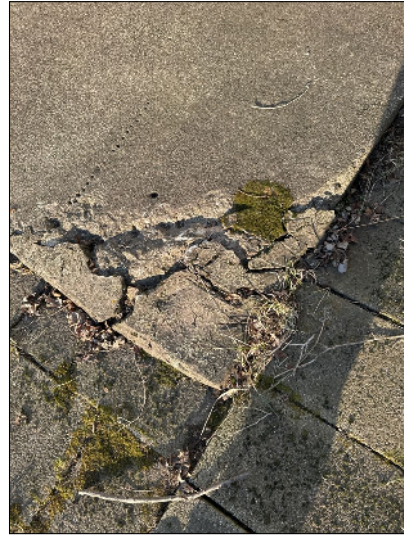
8.2. Damage noted

Damage noted

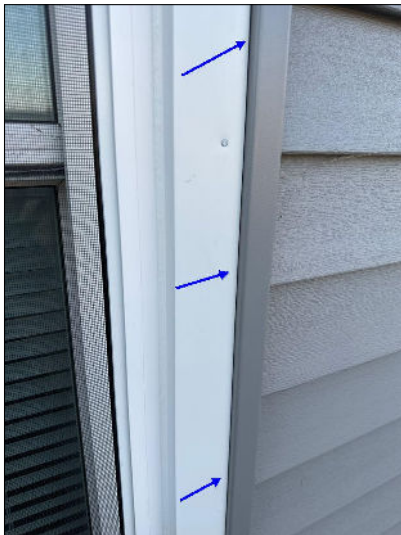
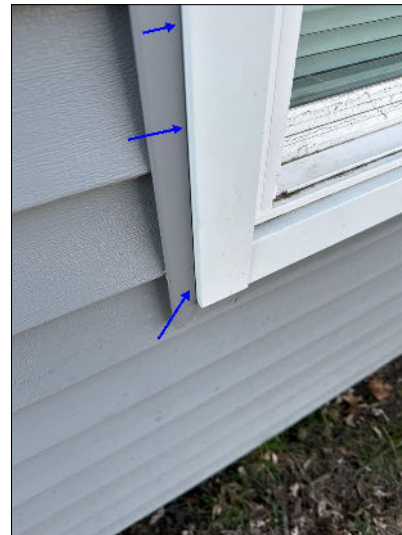
2.2. Caulking missing or ineffective. Caulk and seal all gaps, cracks and openings.

Caulking required.

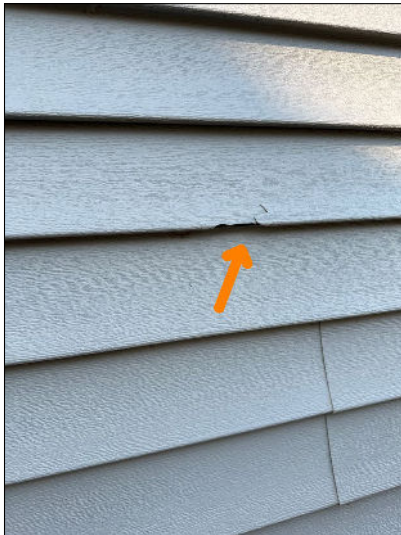
3.2. Damage was observed. Repairs are recommended to prevent water penetration and/or further damage.

Damage left side

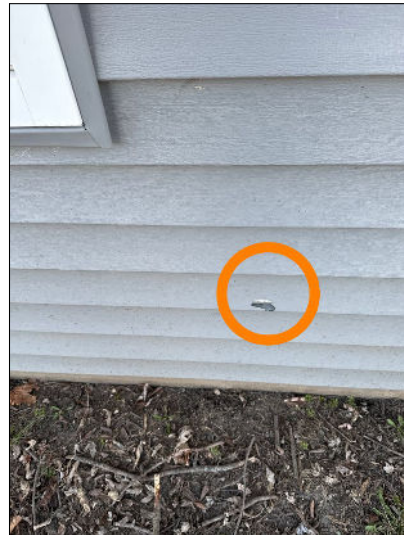
Damage front

Caulk and seal all gaps, cracks and openings.

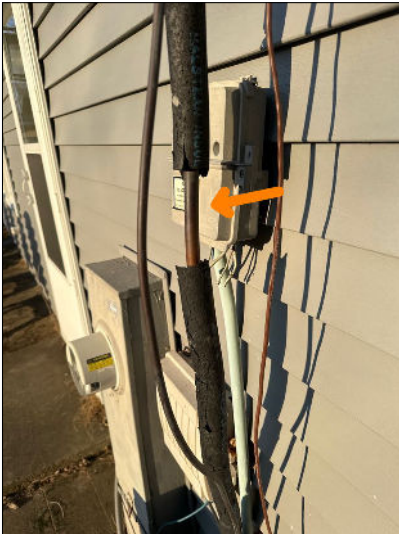
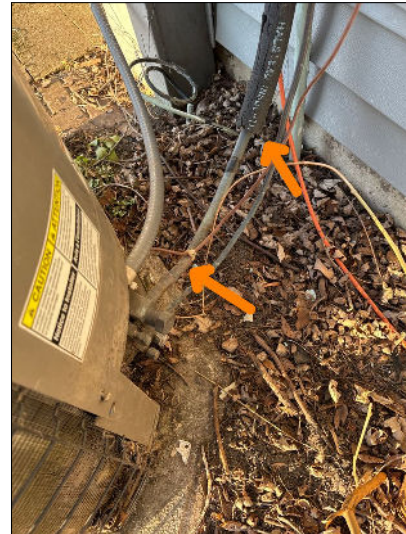
1.1. Missing insulation at A/C unit.

Missing insulation

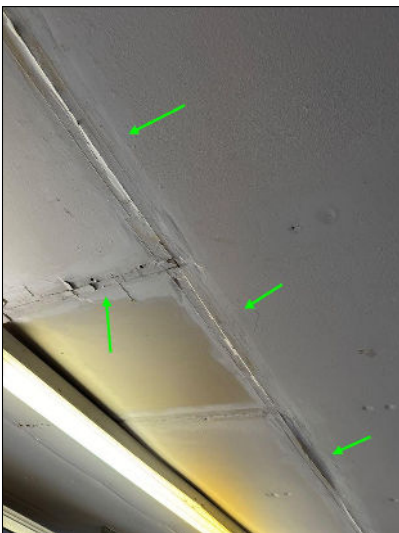
2.2. Failing drywall tape. This is a cosmetic issue, commonly caused by poor application at the time of construction. The joint between panels must be covered with a compound in a specific way - in a series of layers with each layer wider than the last.

2.3. Garage drywall/plaster is patched.

Failing drywall tape/patched area

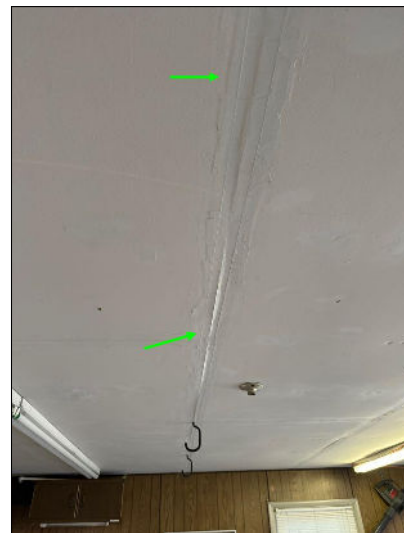
Failing drywall tape

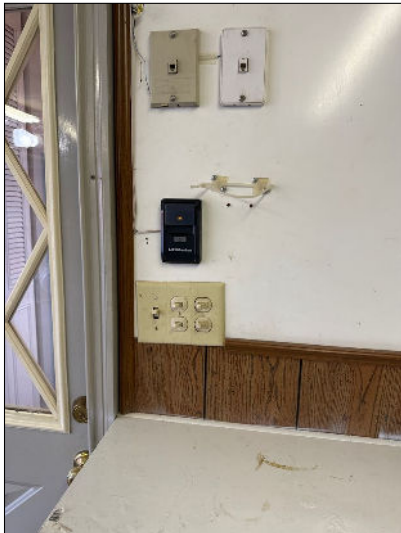
9.2. Switch(es) have unknown function, consult the seller for clarification on what they control.

Switch(es) have unknown function, consult the seller for clarification on what they control.

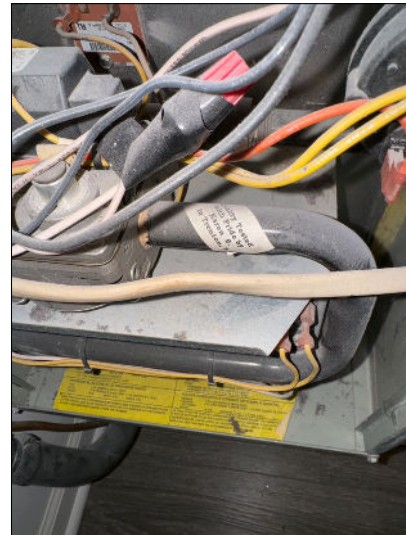
Surface rust/corrosion observed

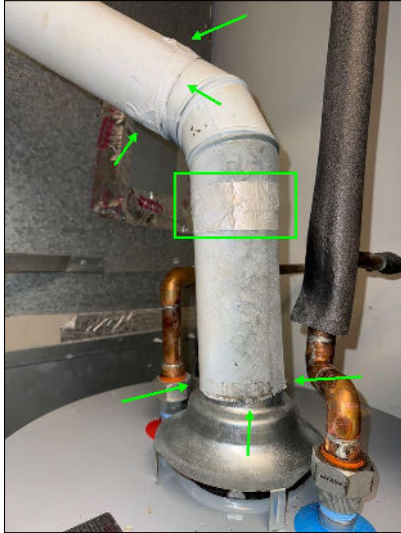
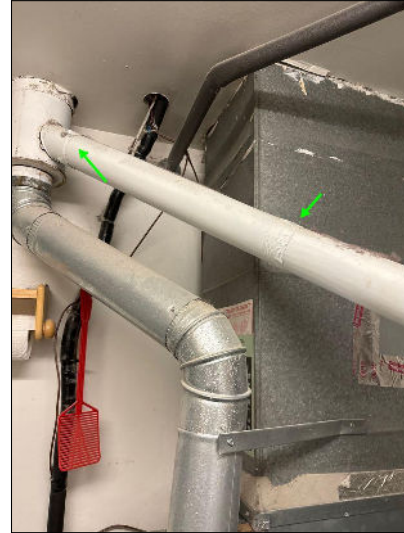
2.2. The vent pipe has tape installed which is not considered appropriate. It will mask/hid the connection. The tape makes it difficult to see the appropriateness and quality of the connection. Joints are to be fastened with three sheet-metal screws and NO tape should be used. Recommend review by an HVAC contractor.

Improper installation

2.1. Joints are to be fastened with three sheet-metal screws and NO tape should be used. Recommend review by an HVAC contractor.

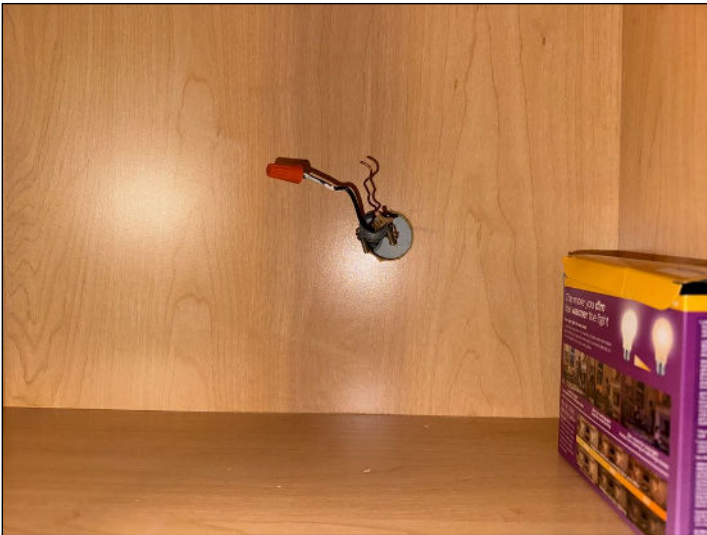
5.3. Wire ends are outside of a Junction Box at. This is a potential shock or electrocution hazard.

Wire ends are outside of a Junction Box at. This is a potential shock or electrocution hazard.

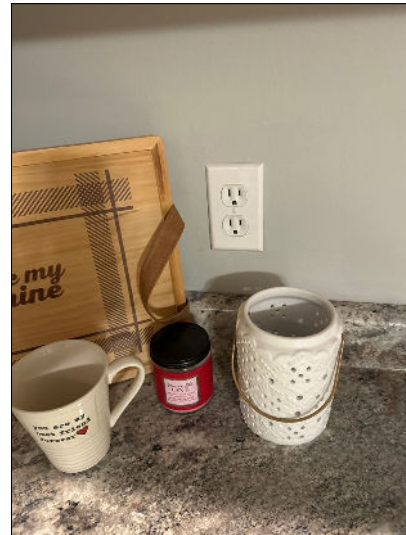
5.2. SAFETY CONCERN: Open Ground. A licensed electrician should be consulted for repairs/replacement as needed to ensure safety.

SAFETY CONCERN: Open Ground. A licensed electrician should be consulted for repairs/replacement as needed to ensure safety.

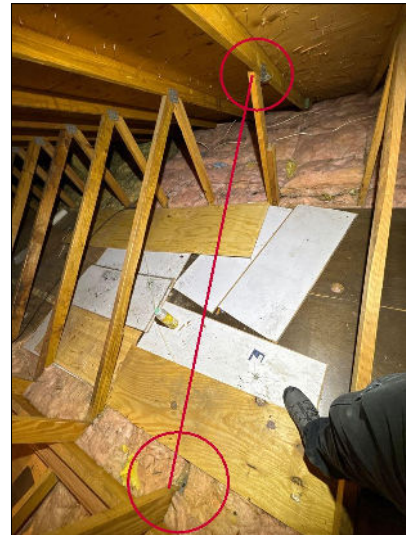
2.5. 2 truss cross members have been removed. This can affect the structural integrity of the attic structure. Recommend review by a qualified contractor.

2 truss cross members have been removed. This can affect the structural integrity of the attic structure. Recommend review by a qualified contractor.

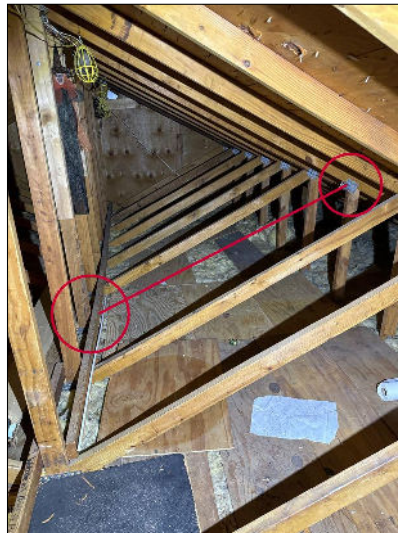
2 truss cross members have been removed. This can affect the structural integrity of the attic structure. Recommend review by a qualified contractor.

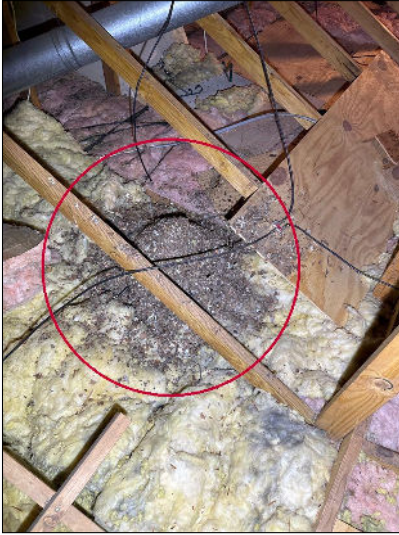
5.2. There is evidence of vermin activity. A pest control specialist should be consulted for treatment and control advice.

There is evidence of vermin activity. A pest control specialist should be consulted for treatment and control advice.

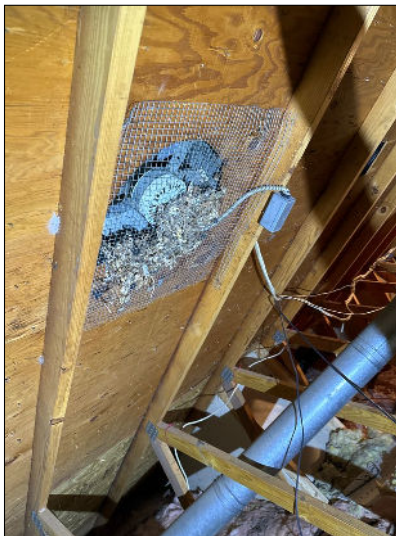
6.3. Power Ventilator was NOT operating during the inspection. Suggest verification of performance prior to closing.

Power Ventilator was NOT operating during the inspection. Suggest verification of performance prior to closing.

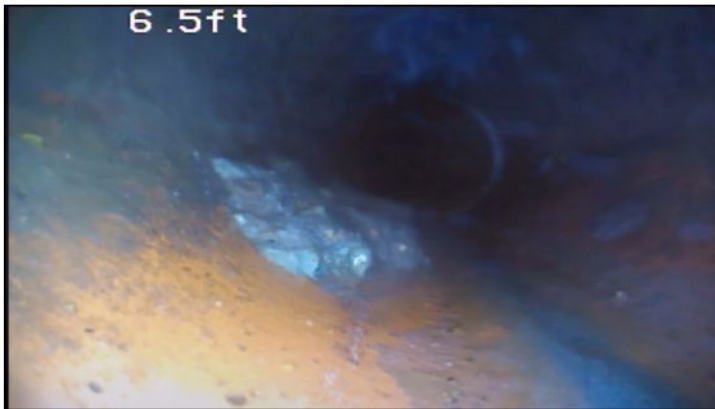
2.5. Deposits/Material buildup noted which are affecting the drainage flow.

Deposits/Material buildup noted which are affecting the drainage flow.

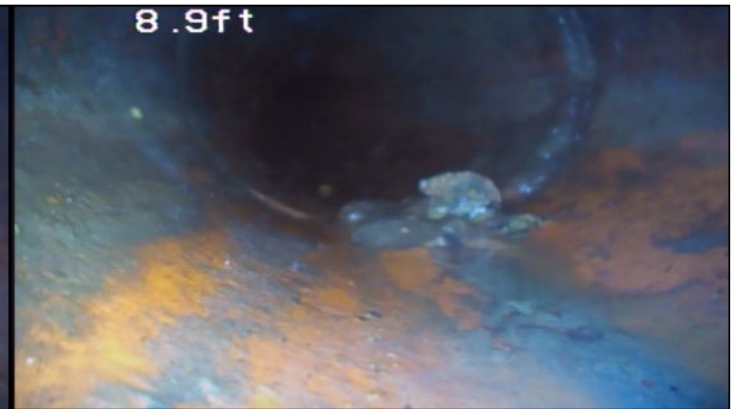
Deposits/Material buildup noted which are affecting the drainage flow.
