# *Prospective Home Inspections*

## Property Inspection Report

56 Sunshine Dr, AnyTown, IL 60538  
Inspection prepared for: Happy Homebuyer  
Real Estate Agent: Chris Prokopiak - Redfin

Date of Inspection: 2/20/2024 Time: 4:00 PM Size: 0  
Order ID: 2113

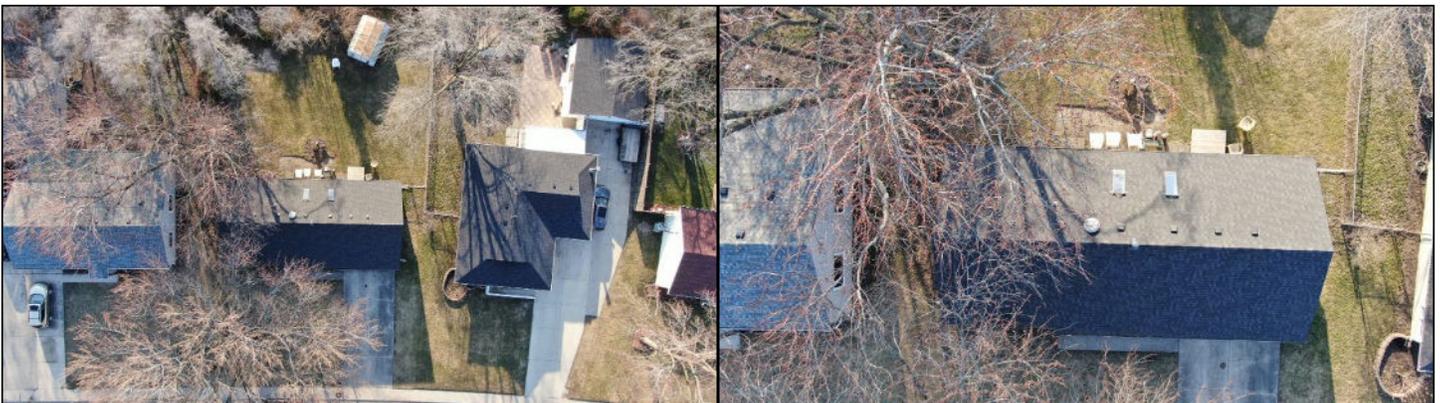
1.4. Tree branches overhanging roof. Trim trees that are in contact or proximity to home, as branches can damage roofing material.

Tree branches overhanging roof

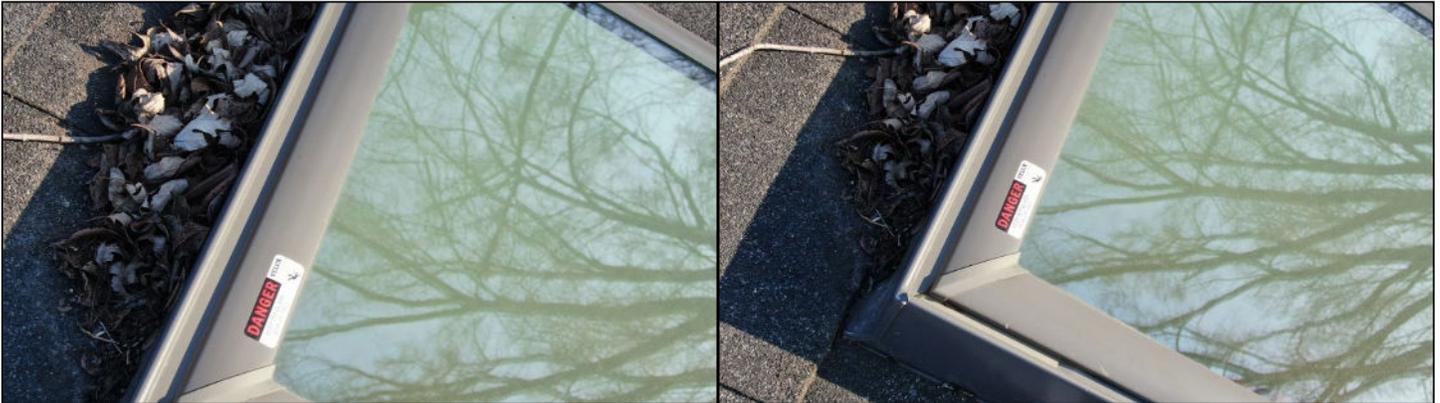
No signs of present or past leaking around the skylight were discovered at time of inspection.

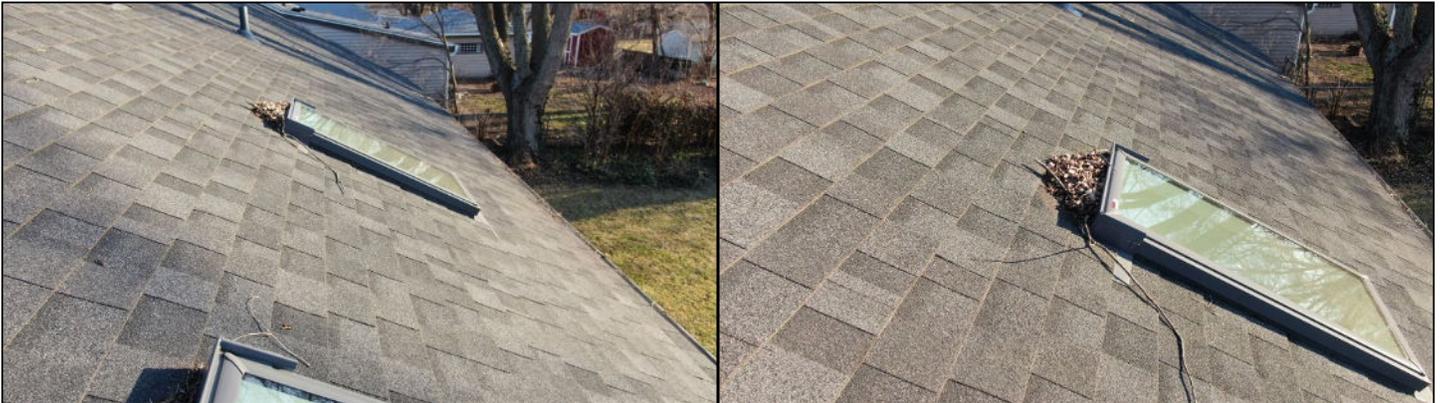
Clean roof areas: Organic debris evident. Debris on Roof surface should be removed to allow for better drainage. Additionally, debris will hold moisture which can shorten the life of the roof covering.

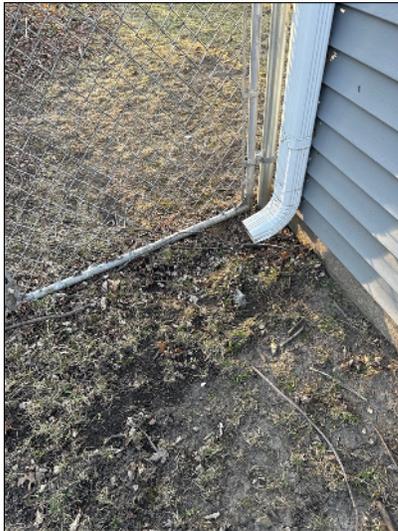
2.2. Extensions missing - downspouts should discharge 6 feet from building and be routed to discharge away from the homes foundation, this will reduce the potential for water to seep into the basement.

Extensions missing

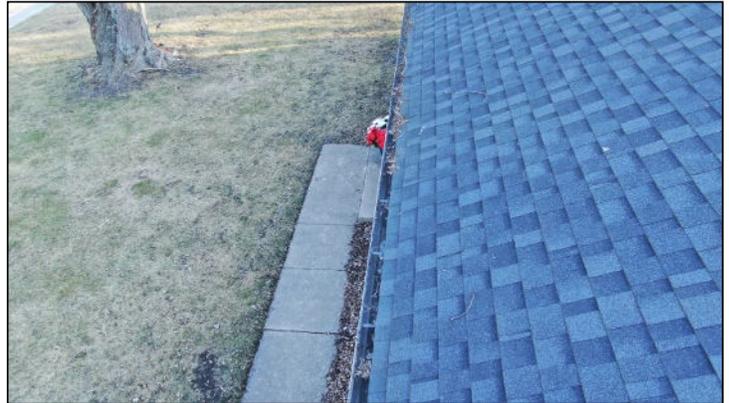
Gutters need to be cleaned.

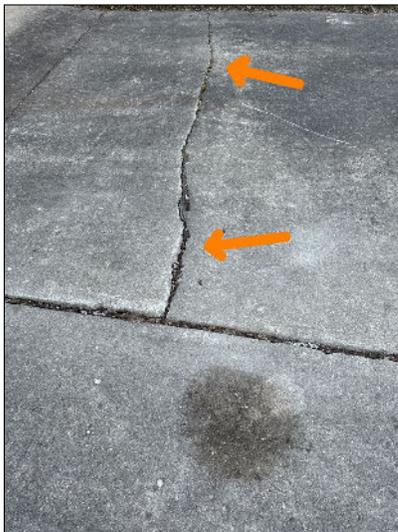
Potential Trip Hazard(s) at driveway/sidewalk; monitor / repair as necessary

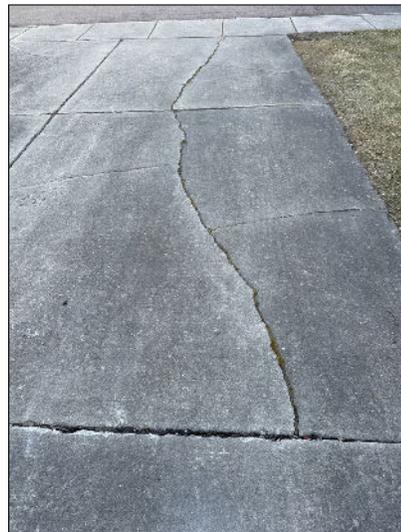
1.1. Cracks / Damage were observed. Further deterioration will occur as water expands and contracts from freeze and thaw cycles.

Cracks noted.

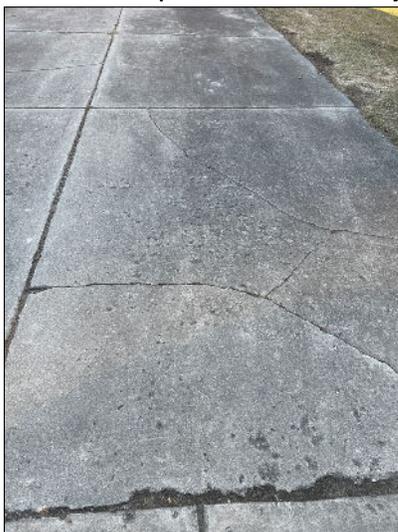
Cracks noted.

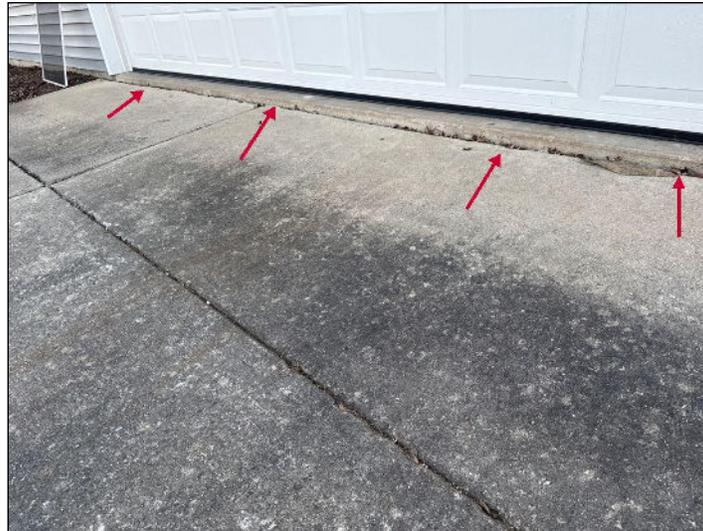
Potential Trip Hazard(s) at driveway/sidewalk; monitor / repair as necessary

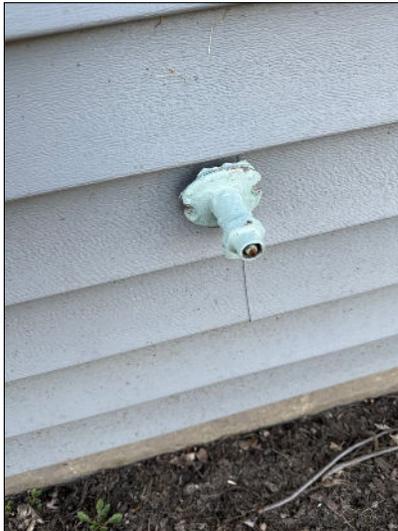
Missing / Broken handle noted at the time of the inspection on Front

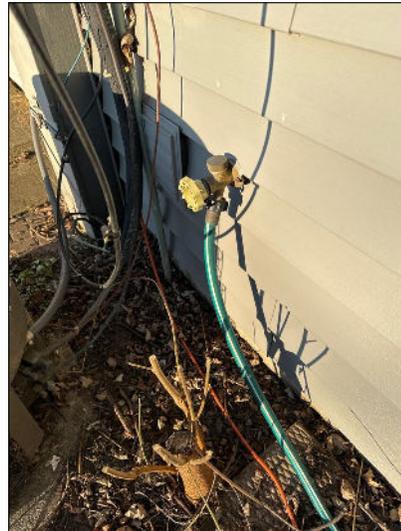
5.1. Exterior faucets have hoses attached during winter, once weather turns below 32° pipe damage may occur.

Hoses attached

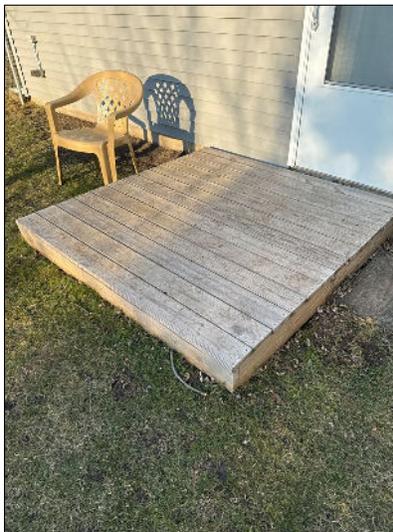
7.2. Paint or Stain is needed on the deck flooring

Paint/Stain needed

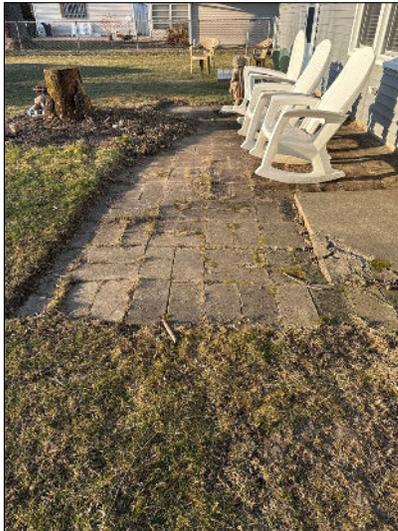
Uneven slabs/sunken/settled areas at the patio.

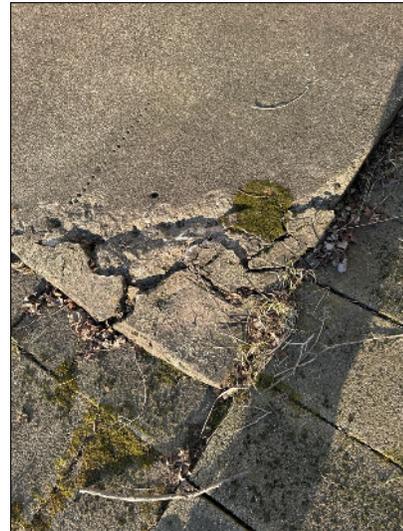
Damage noted

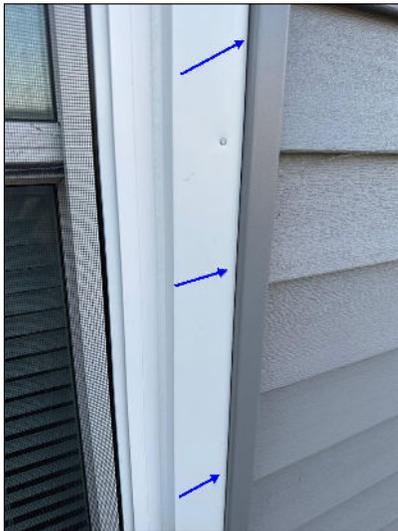
2.2. Caulking missing or ineffective. Caulk and seal all gaps, cracks and openings.

Caulking required.

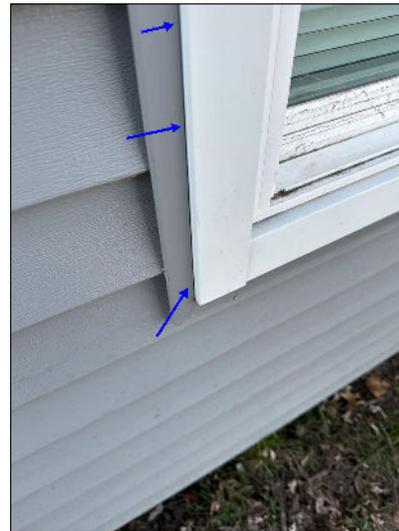
Caulking required.

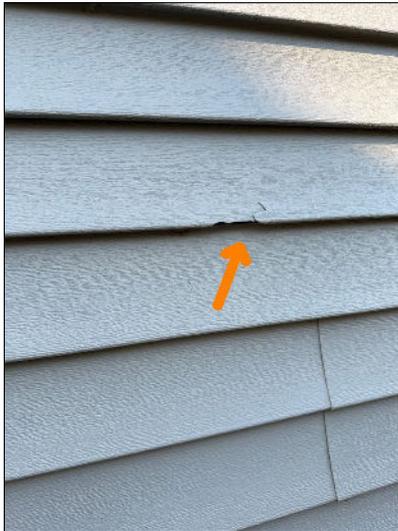
3.2. Damage was observed. Repairs are recommended to prevent water penetration and/or further damage.

Damage left side

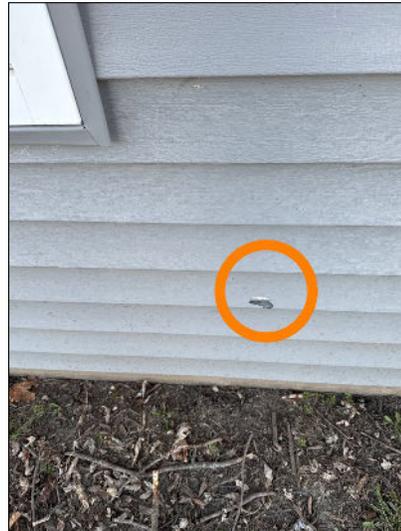
Damage front

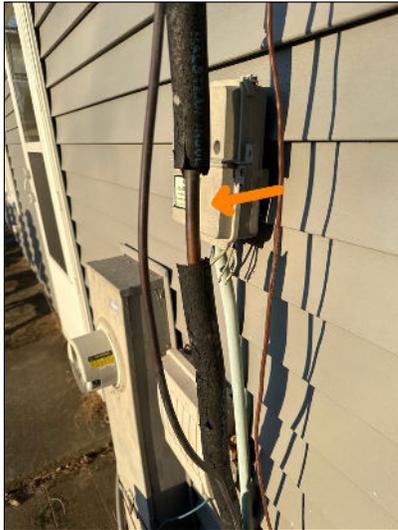
### 1.1. Missing insulation at A/C unit.

Missing insulation

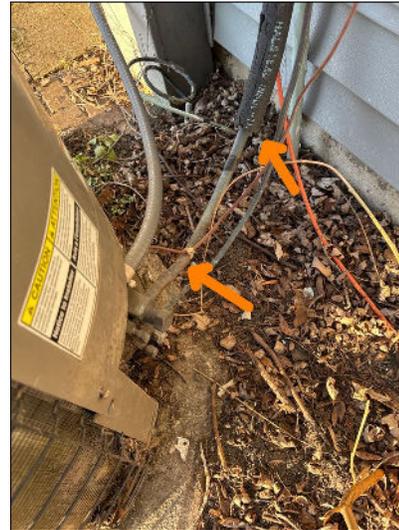
Missing insulation

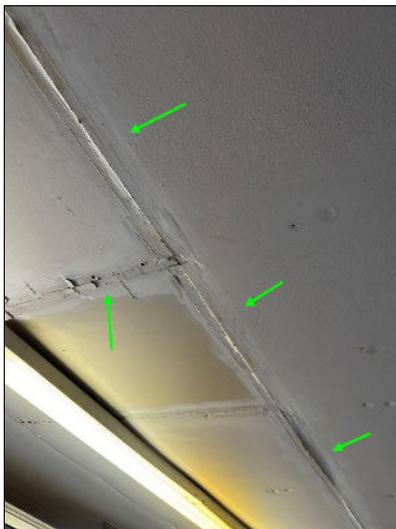
2.2. Failing drywall tape. This is a cosmetic issue, commonly caused by poor application at the time of construction. The joint between panels must be covered with a compound in a specific way - in a series of layers with each layer wider than the last.

2.3. Garage drywall/plaster is patched.

Failing drywall tape/patched area

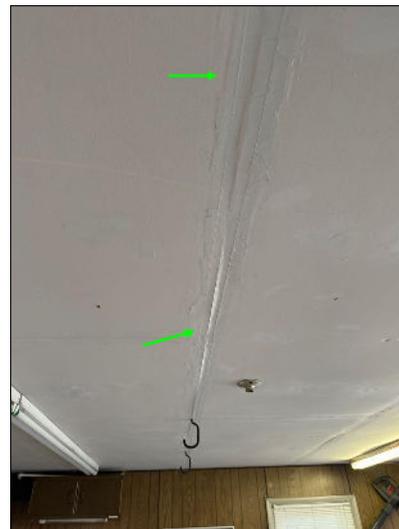
Failing drywall tape

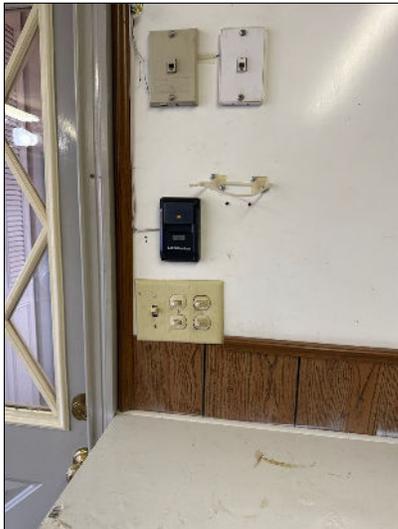
Switch(es) have unknown function, consult the seller for clarification on what they control.

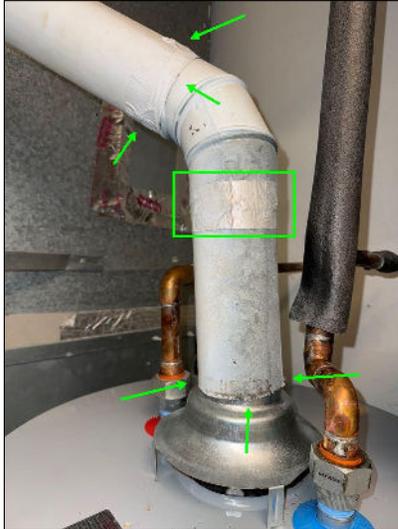
2.2. The vent pipe has tape installed which is not considered appropriate. It will mask/hid the connection. The tape makes it difficult to see the appropriateness and quality of the connection. Joints are to be fastened with three sheet-metal screws and NO tape should be used. Recommend review by an HVAC contractor.

Improper installation

2.1. Joints are to be fastened with three sheet-metal screws and NO tape should be used. Recommend review by an HVAC contractor.

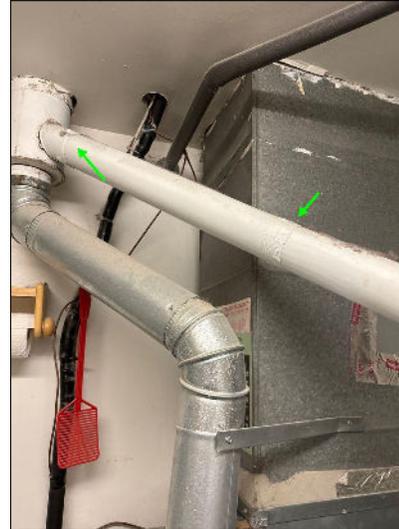
Improper installation

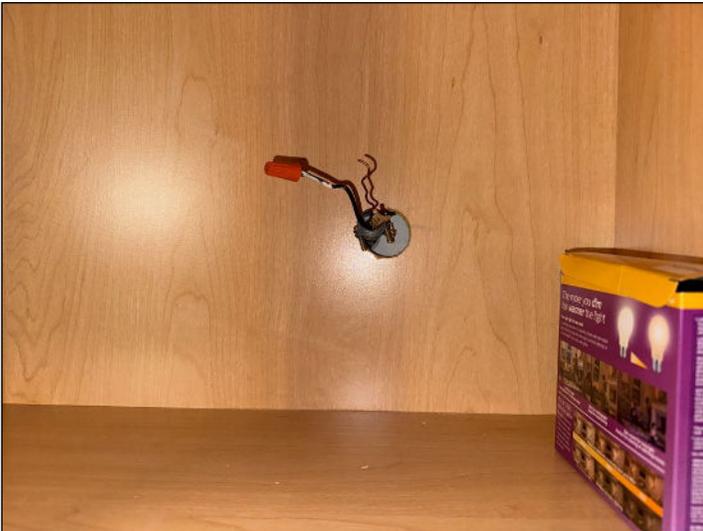
Wire ends are outside of a Junction Box at. This is a potential shock or electrocution hazard.

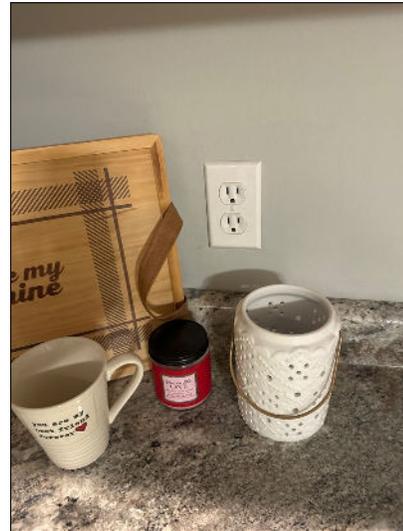
**SAFETY CONCERN:** Open Ground. A licensed electrician should be consulted for repairs/replacement as needed to ensure safety.

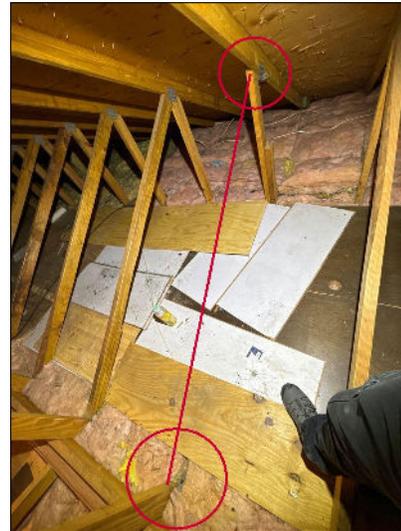
2 truss cross members have been removed. This can affect the structural integrity of the attic structure. Recommend review by a qualified contractor.

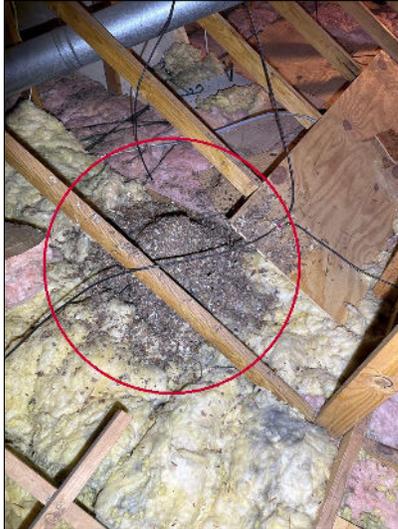
There is evidence of vermin activity. A pest control specialist should be consulted for treatment and control advice.

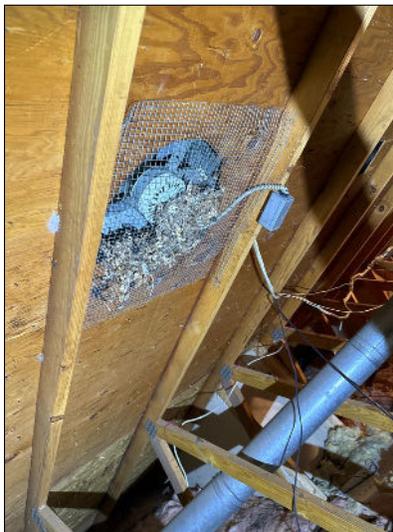
Power Ventilator was NOT operating during the inspection. Suggest verification of performance prior to closing.

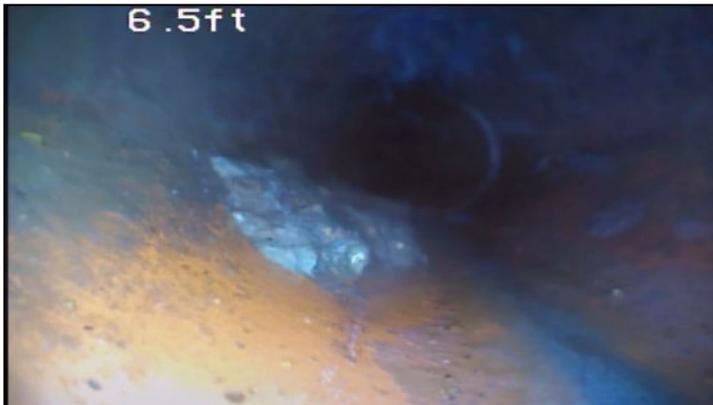
2.5. Deposits/Material buildup noted which are affecting the drainage flow.

Deposits/Material buildup noted which are affecting the drainage flow.

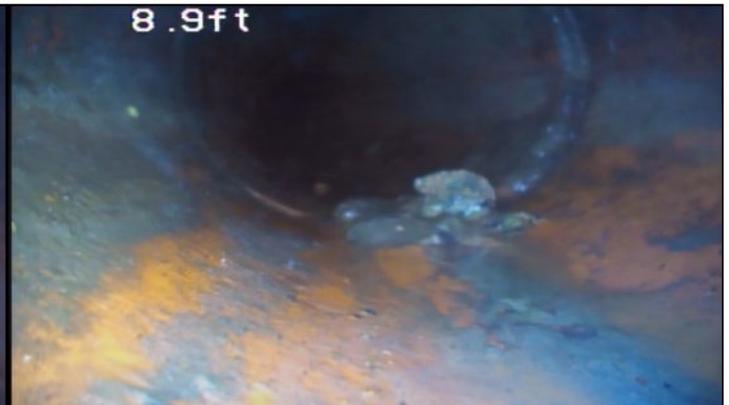
Deposits/Material buildup noted which are affecting the drainage flow.

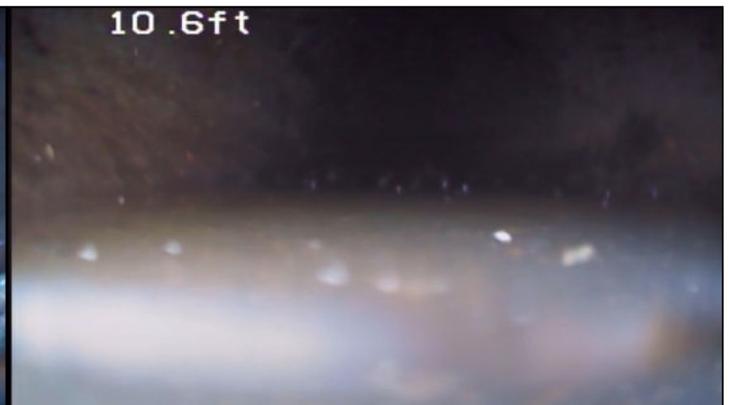
Belly noted.
