Prospective Home Inspections

Property Inspection Report

56 Sunshine Dr, AnyTown, IL 60538
Inspection prepared for: Happy Homebuyer
Real Estate Agent: Chris Prokopiak - Redfin

Date of Inspection: 2/20/2024 Time: 4:00 PM Size: 0
Order ID: 2113

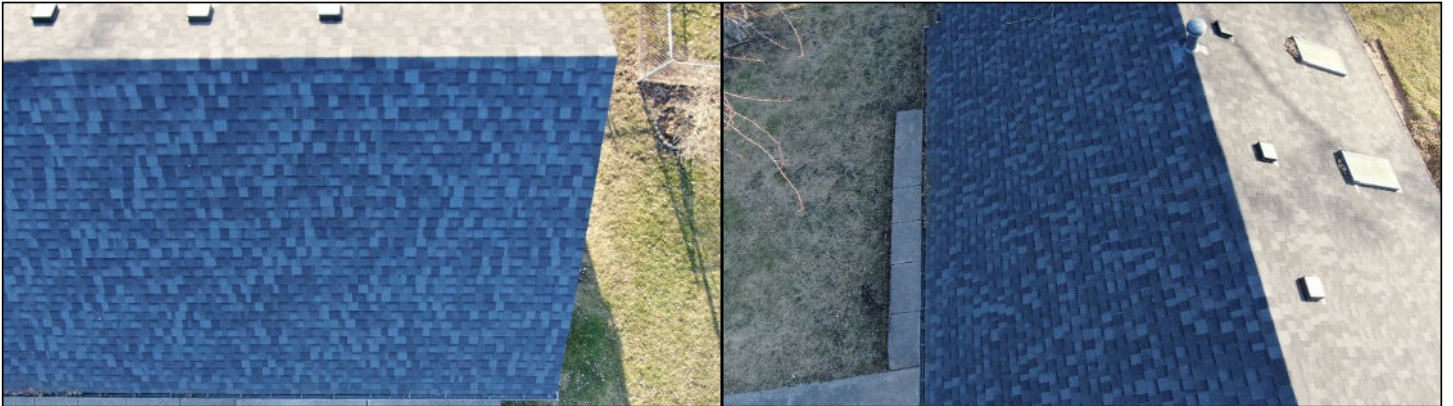
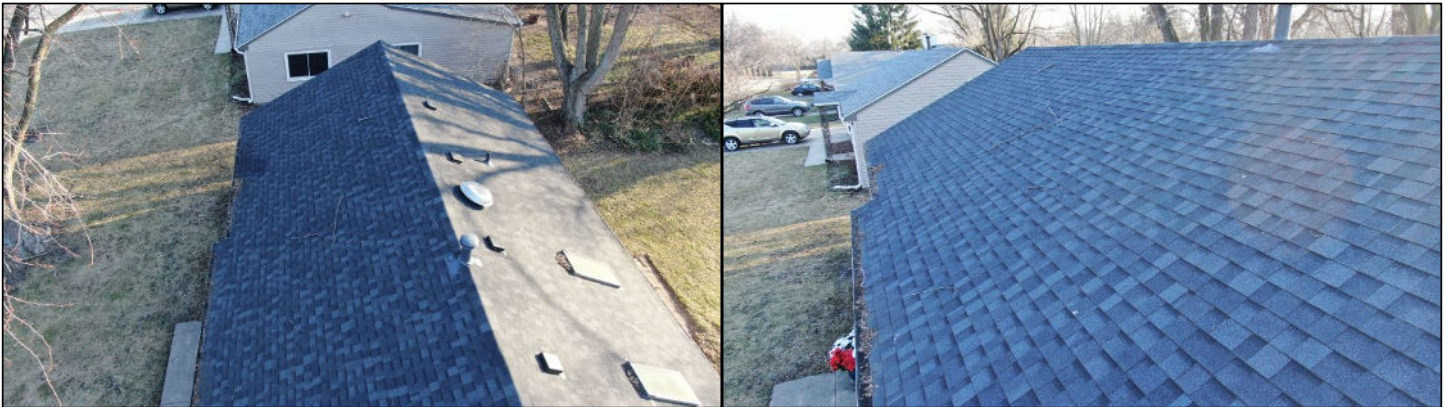
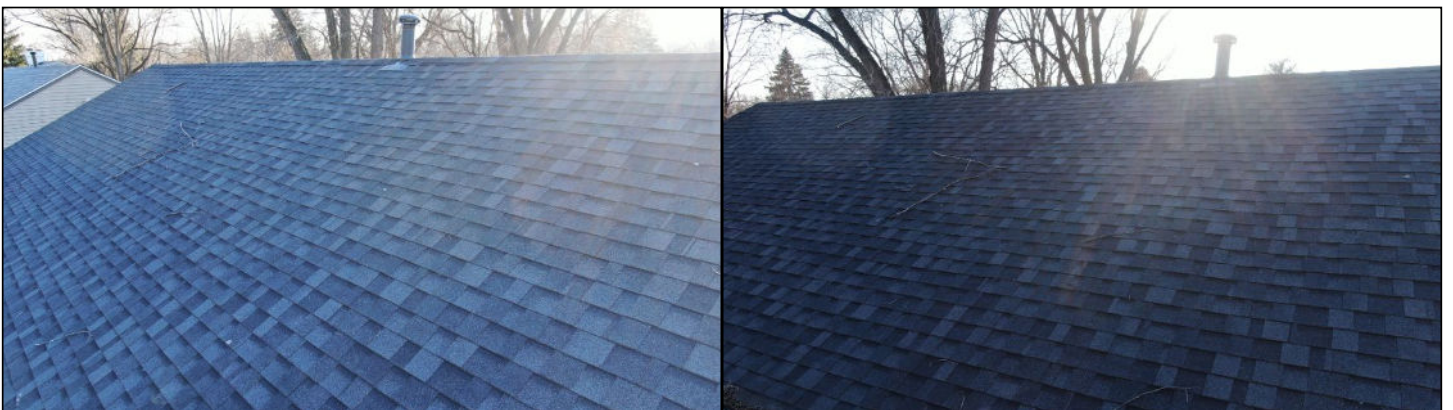
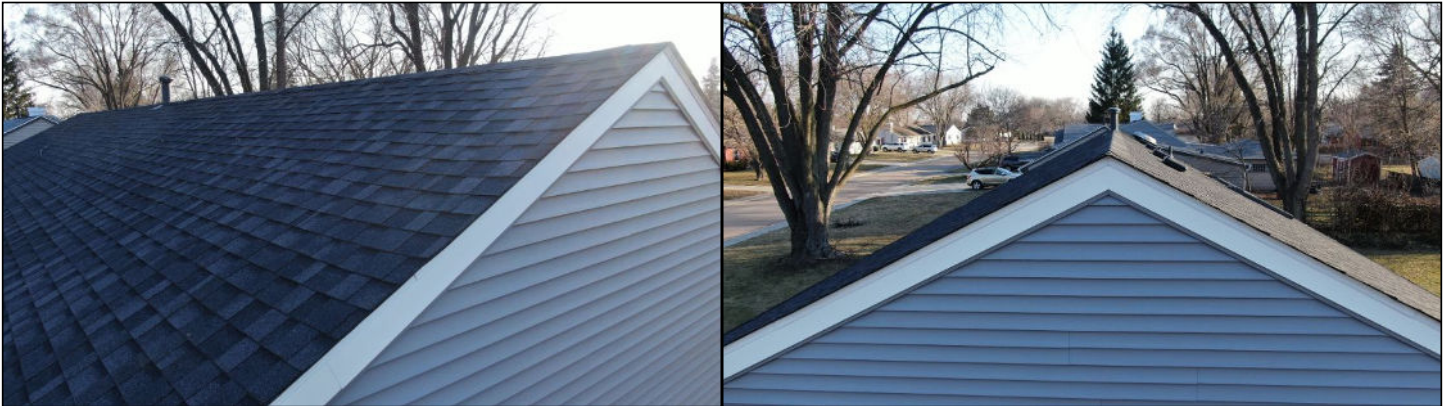
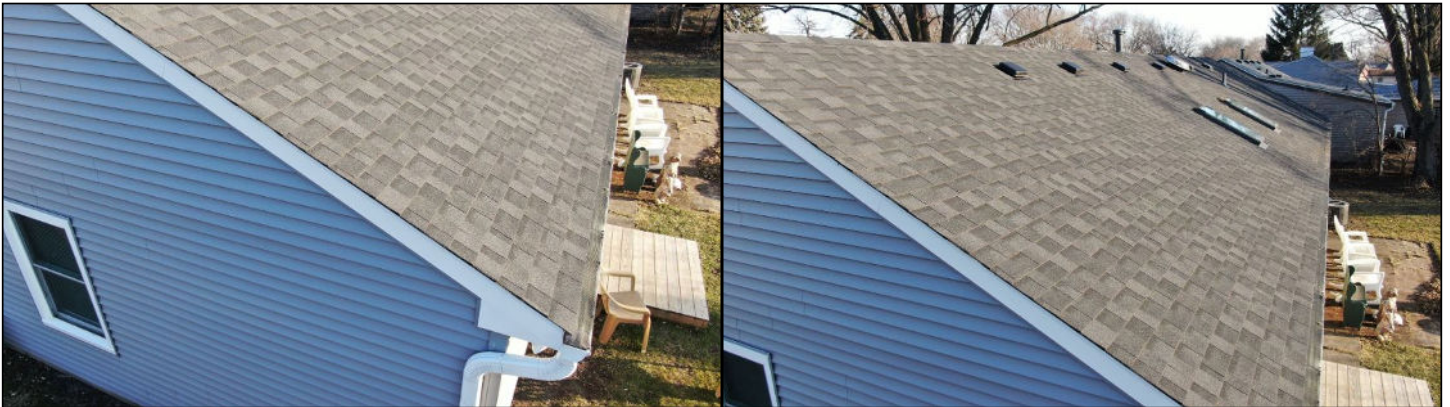
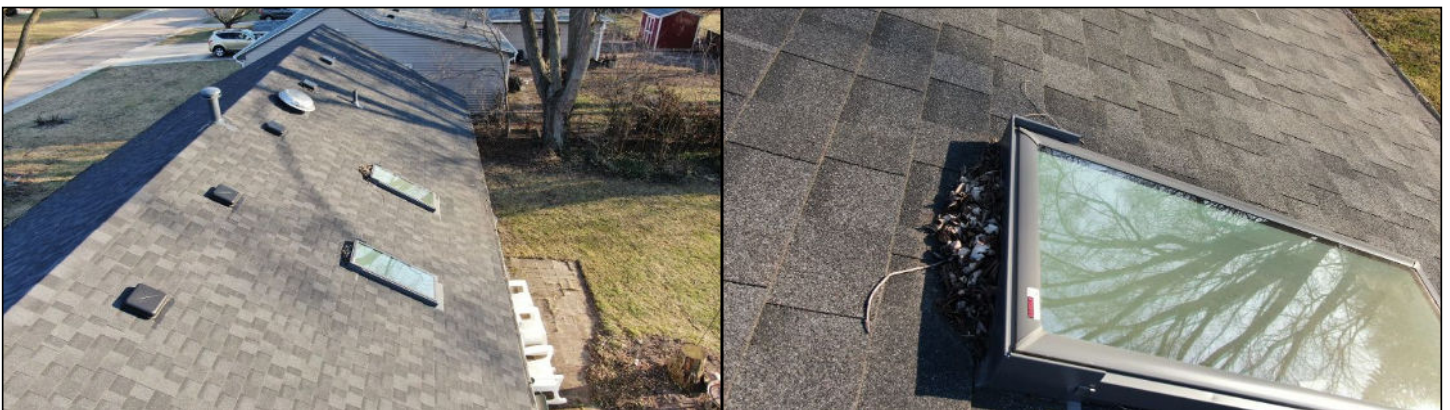
Page 12 Item: 1	Condition	1.4. Tree branches overhanging roof. Trim trees that are in contact or proximity to home, as branches can damage roofing material.
-----------------	-----------	--

Tree branches overhanging roof

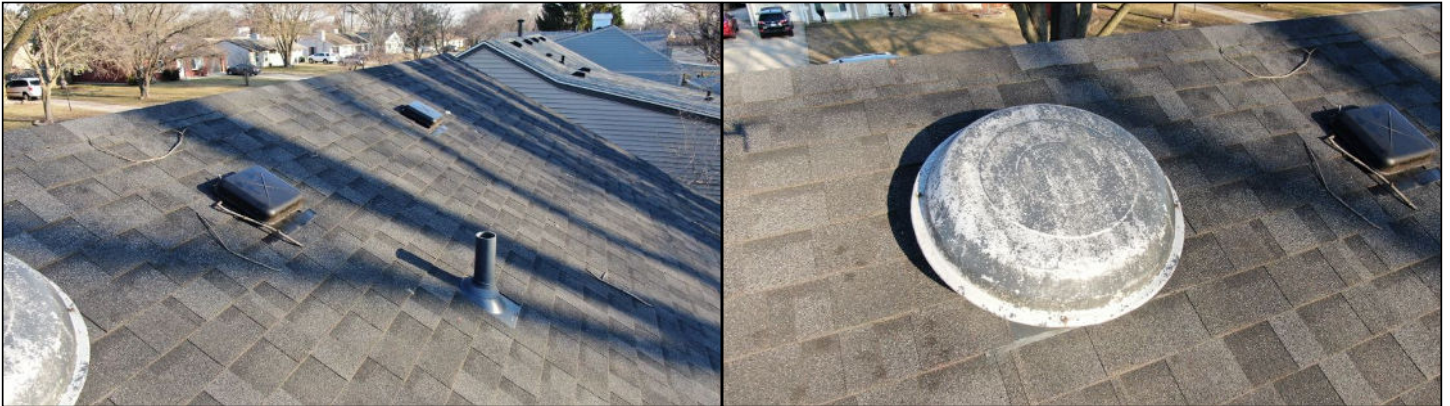
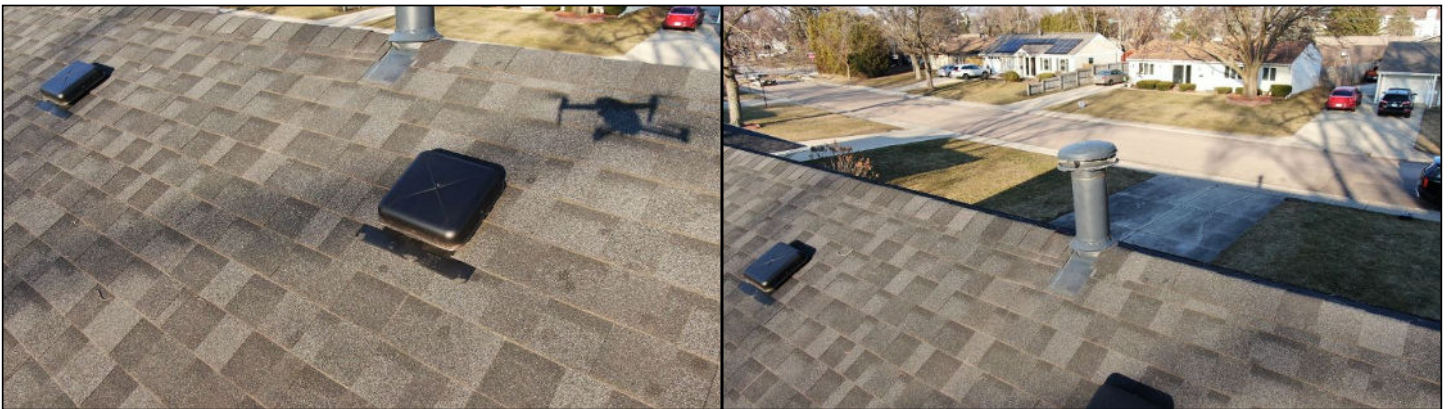
Clean roof areas: Organic debris evident. Debris on Roof surface should be removed to allow for better drainage. Additionally, debris will hold moisture which can shorten the life of the roof covering.

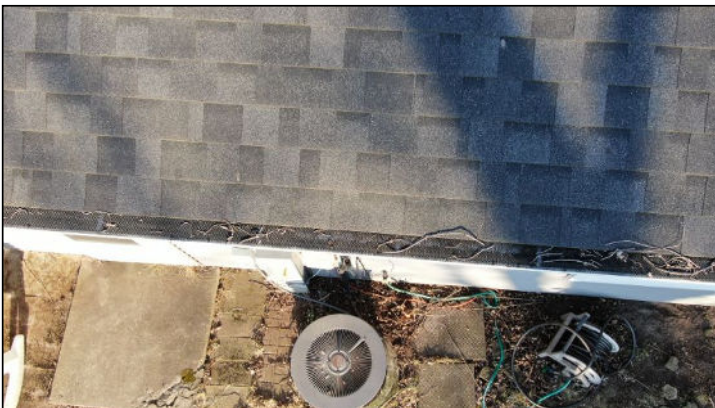
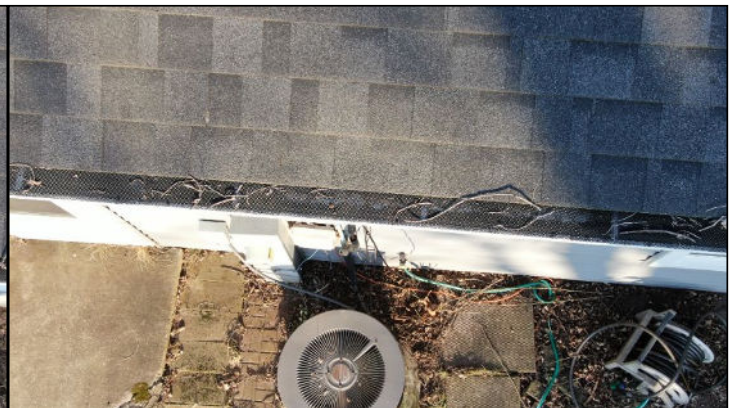
Gutters need to be cleaned.

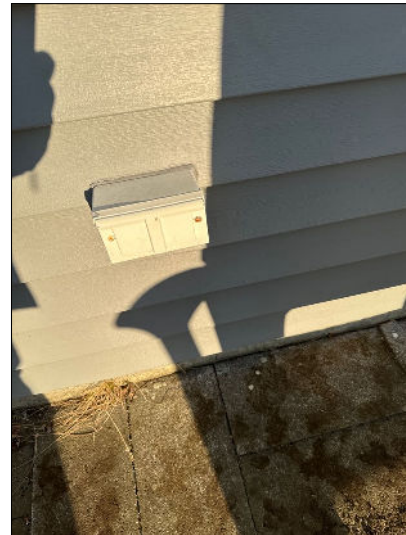
4.2. GFCI Outlet at - Rear did not trip when tested.

GFCI Outlet at - Rear did not trip when tested.

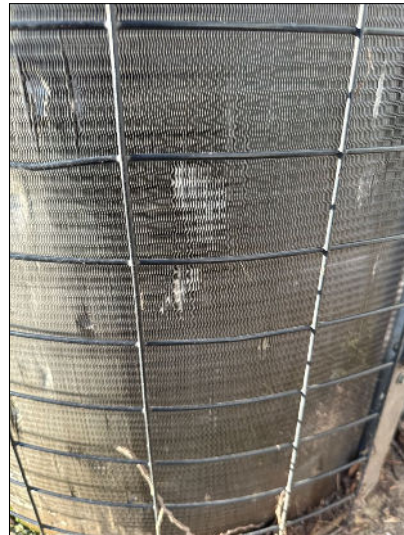
Dirty/Obstructed fins

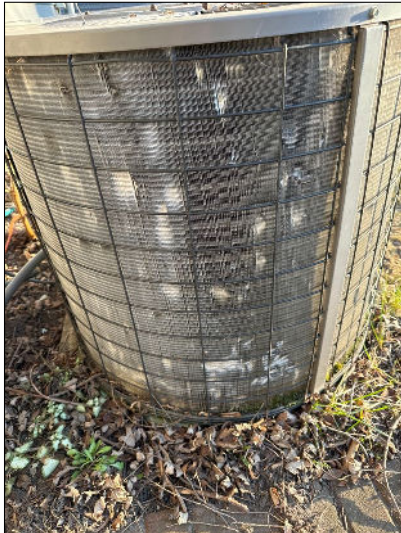
Dirty/Obstructed fins

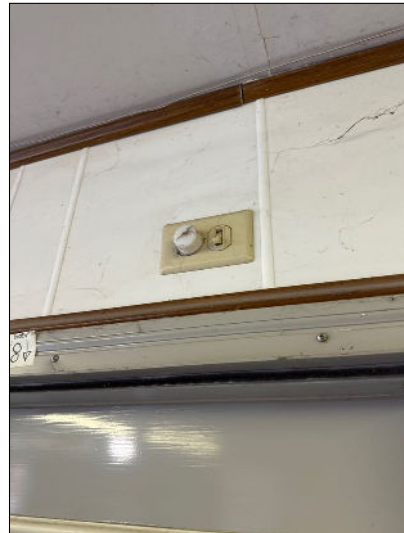
Switch(es) have unknown function, consult the seller for clarification on what they control.

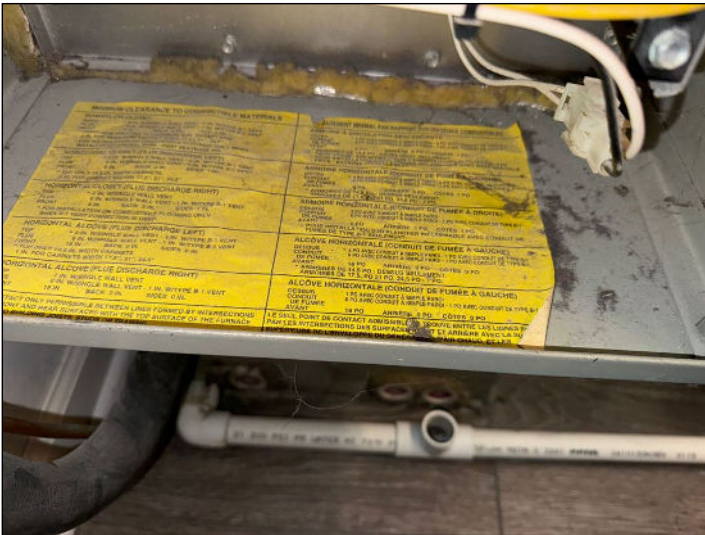
Dirt/dust buildup

Plan for a service company to inspect and clean the HVAC system after possession of the property. An annual maintenance is recommended to keep the HVAC system working at its proper efficiency.

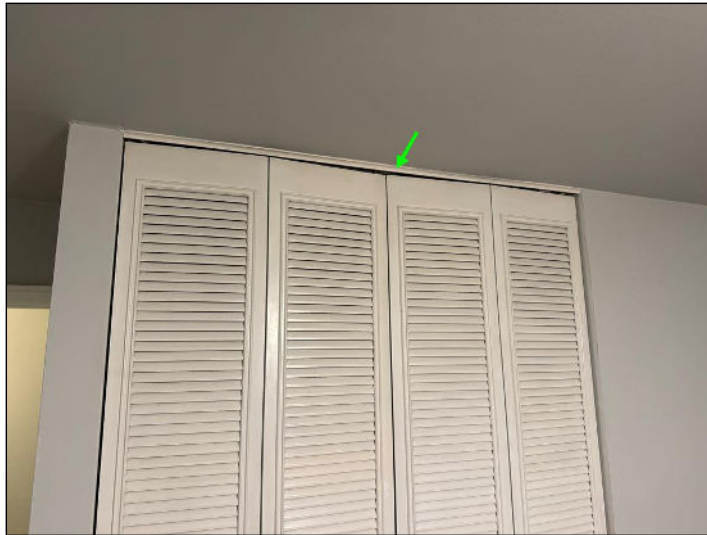
6.1. The closet door binds or drags.

The closet door binds or drags.

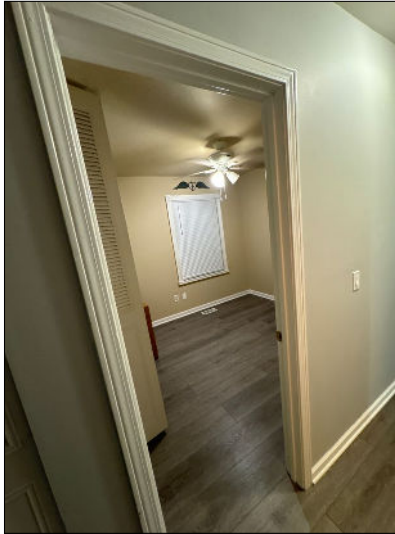
1.1. Door missing / NOT installed.

Door missing / NOT installed.

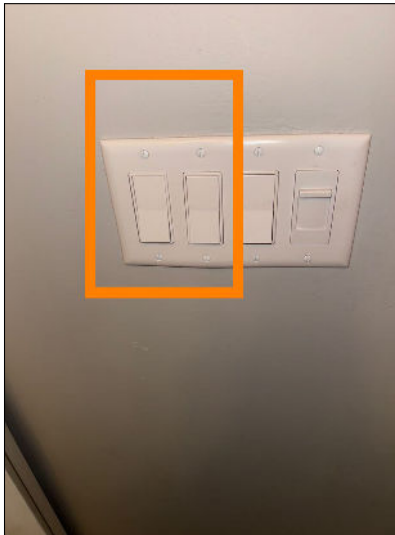
3.2. Switch(es) have unknown function, consult the seller for clarification on what they control.

Switch(es) have unknown function, consult the seller for clarification on what they control.

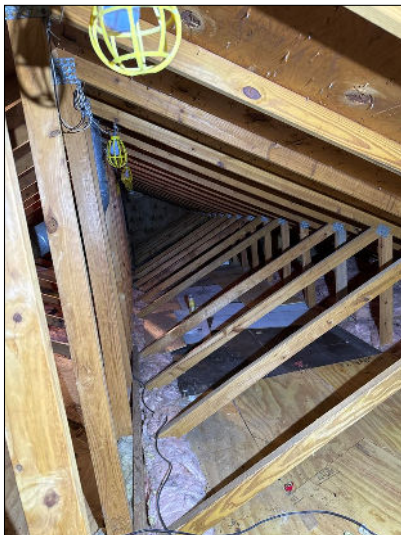
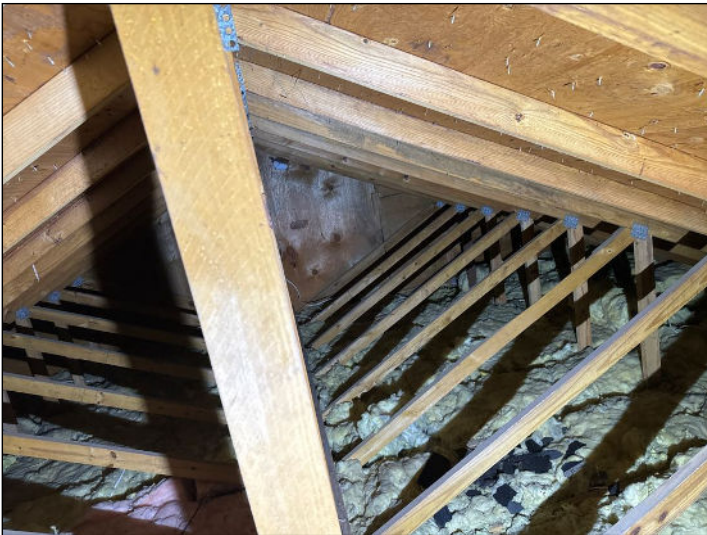
Attic Structure

2.5. 2 truss cross members have been removed. This can affect the structural integrity of the attic structure. Recommend review by a qualified contractor.

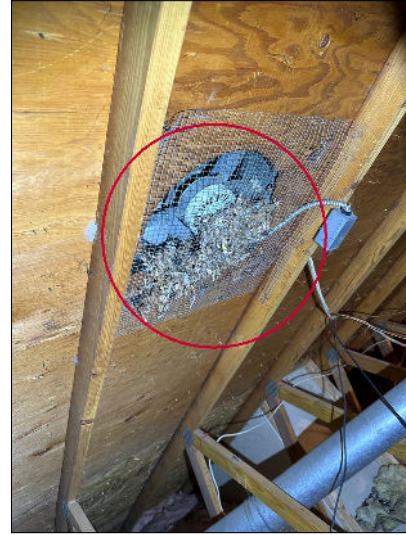
There is evidence of vermin activity. A pest control specialist should be consulted for treatment and control advice.

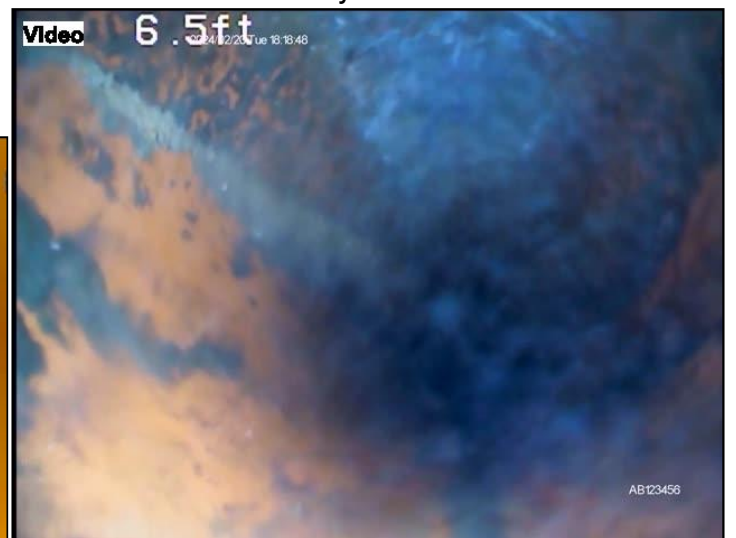
2.2. An obstruction was noted.

An obstruction was noted.

3.2. The obstruction needs to be removed to prevent blockage of wastewater through the pipe. Recommend evaluating the area(s) for repairs.
