# *Prospective Home Inspections*

## Property Inspection Report

56 Sunshine Dr, AnyTown, IL 60538  
Inspection prepared for: Happy Homebuyer  
Real Estate Agent: Chris Prokopiak - Redfin

Date of Inspection: 2/20/2024 Time: 4:00 PM Size: 0  
Order ID: 2113

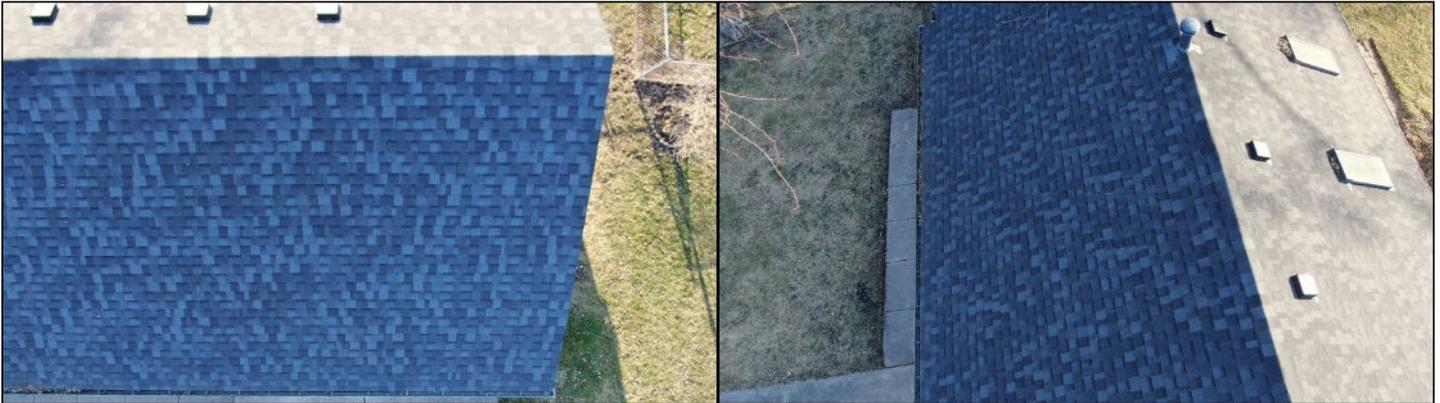
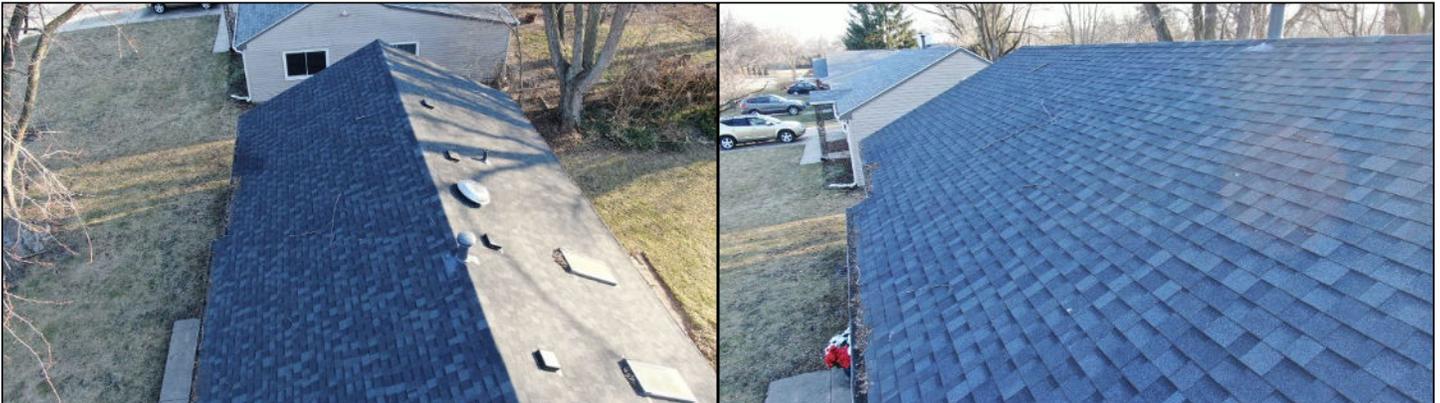
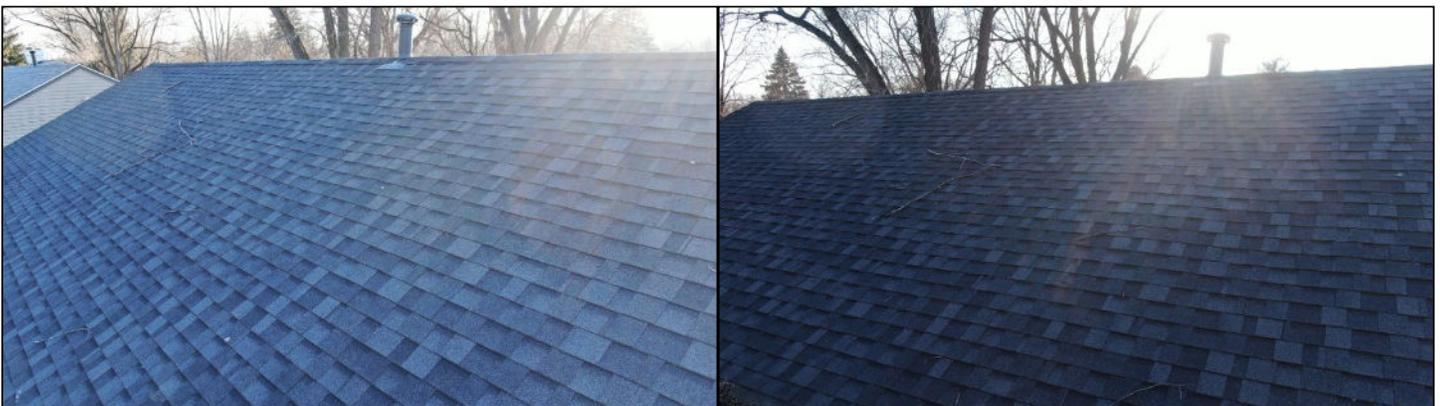
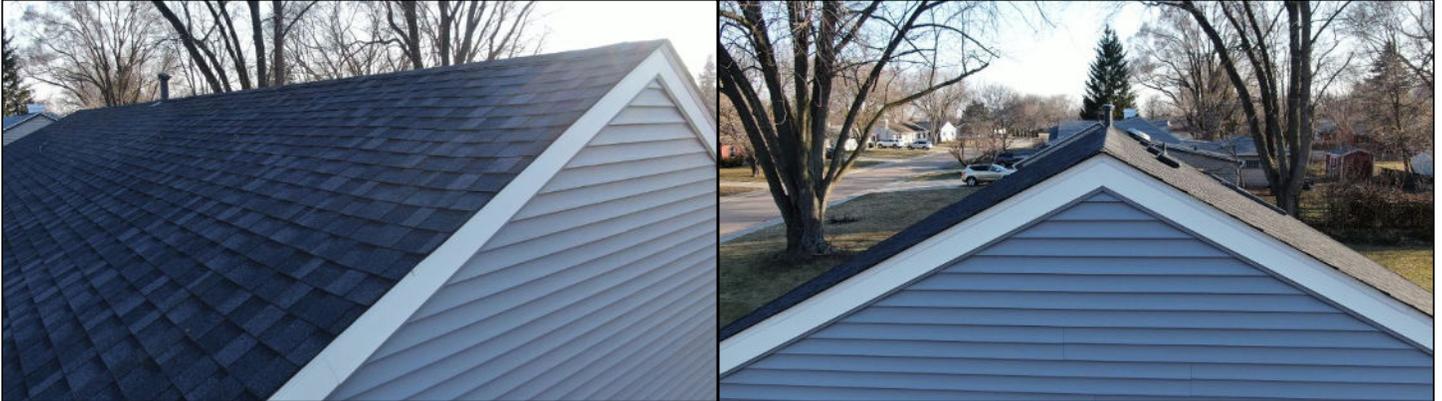
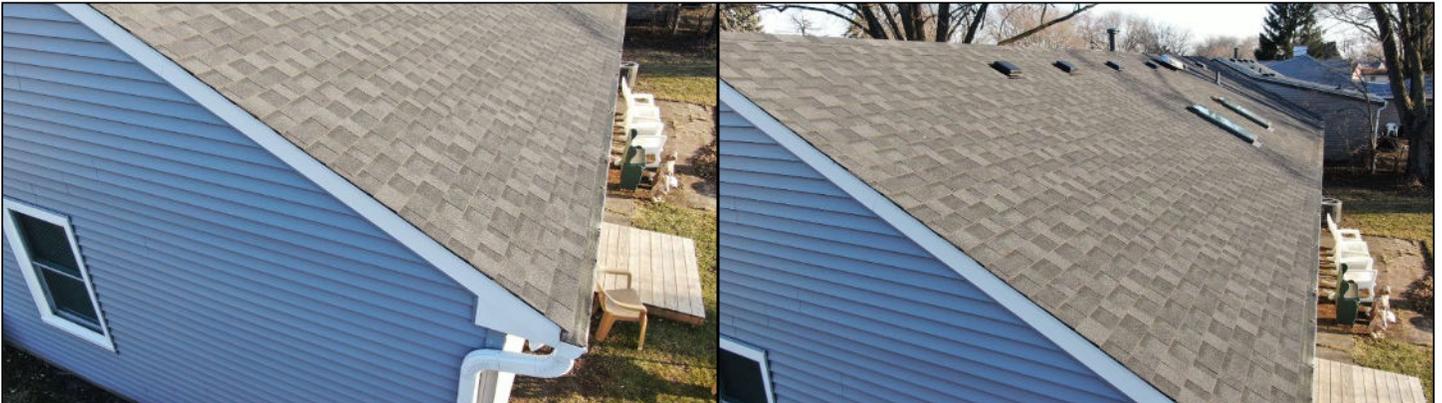
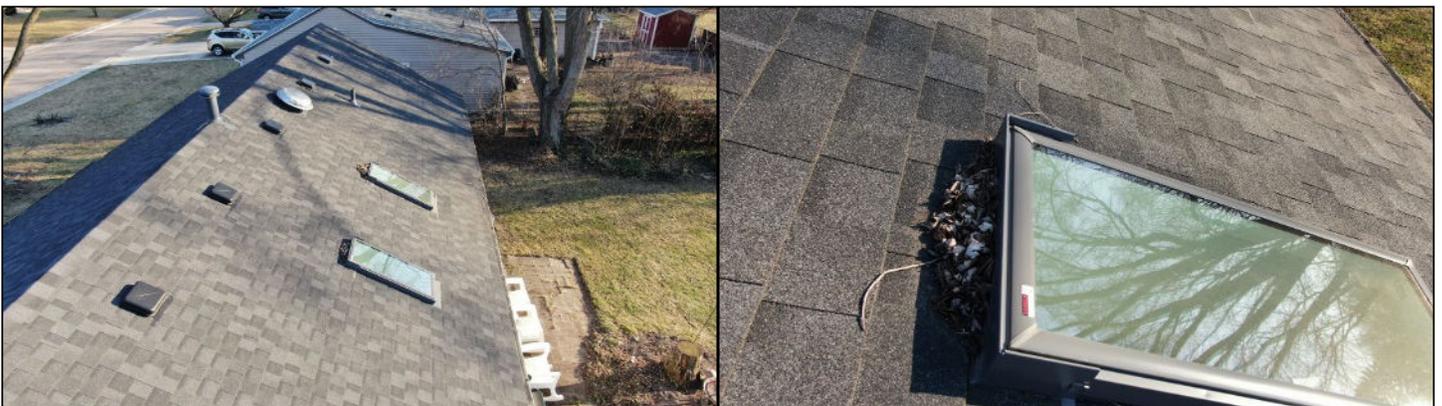
Tree branches overhanging roof

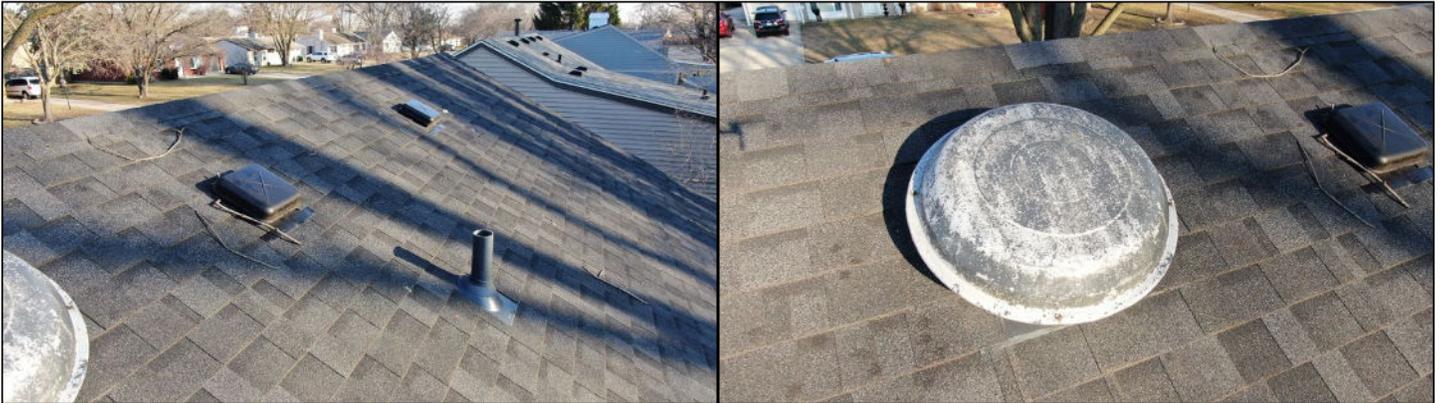
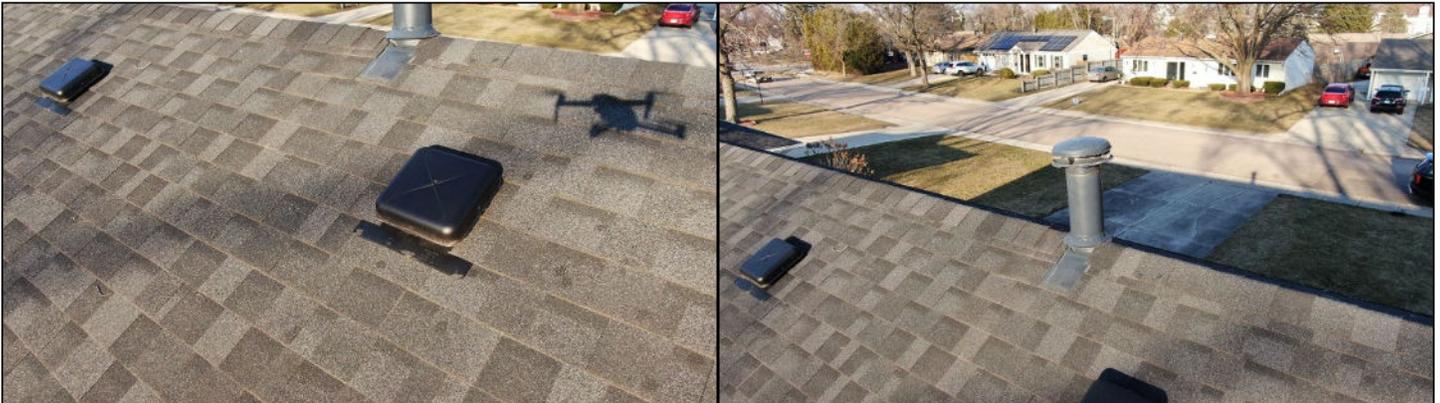
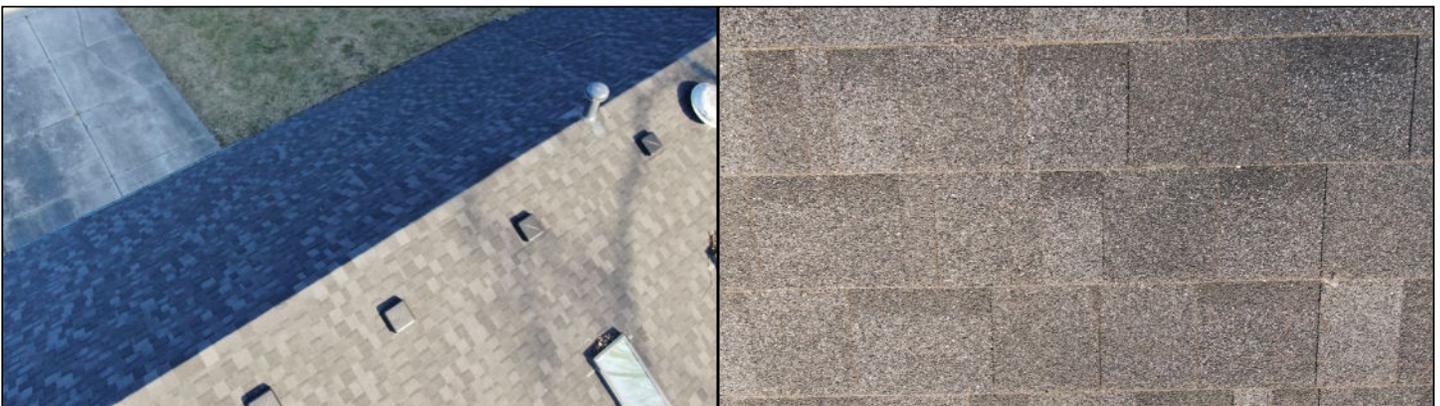
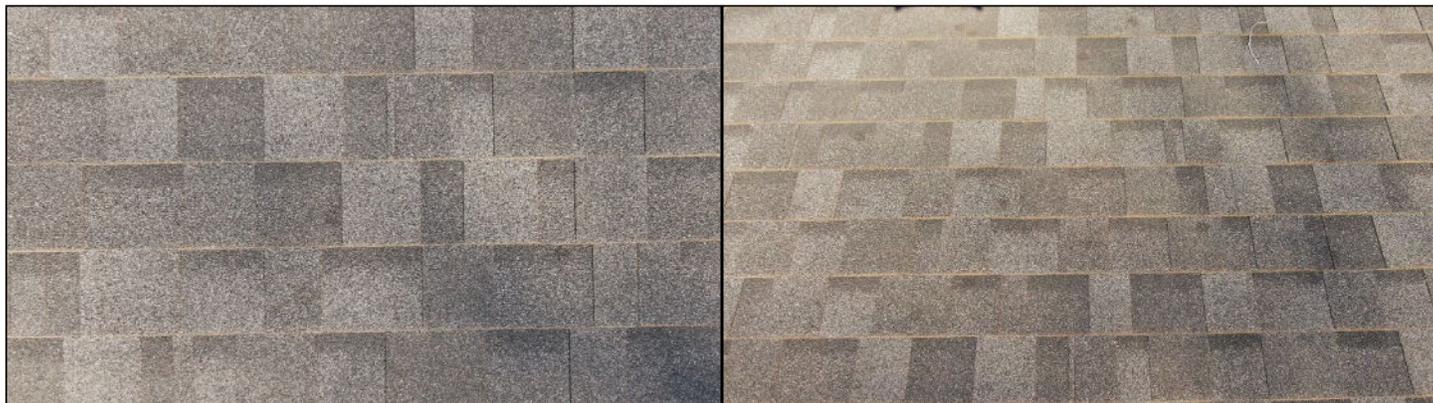
Clean roof areas: Organic debris evident. Debris on Roof surface should be removed to allow for better drainage. Additionally, debris will hold moisture which can shorten the life of the roof covering.

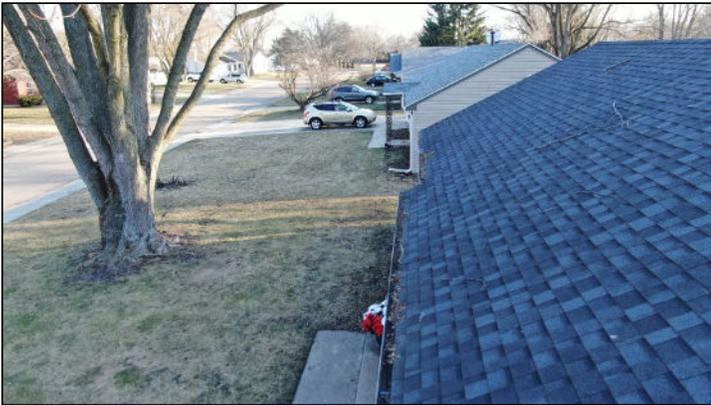
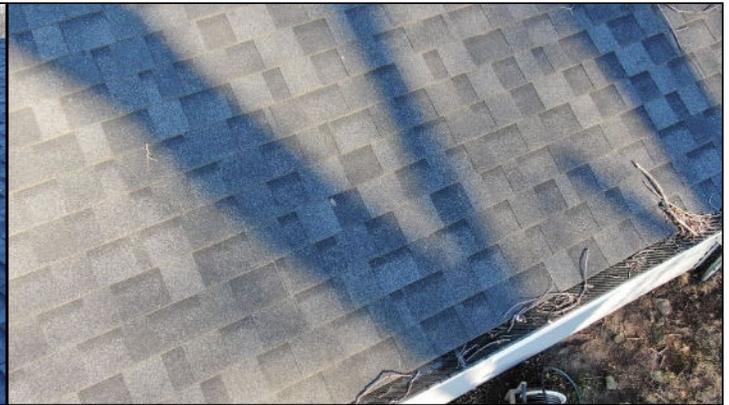
Gutters need to be cleaned.

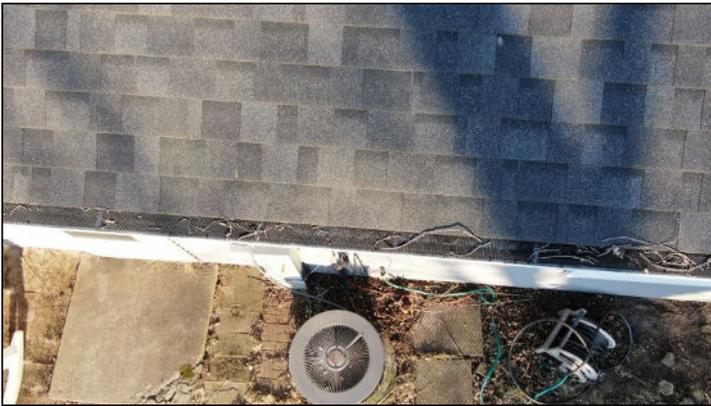
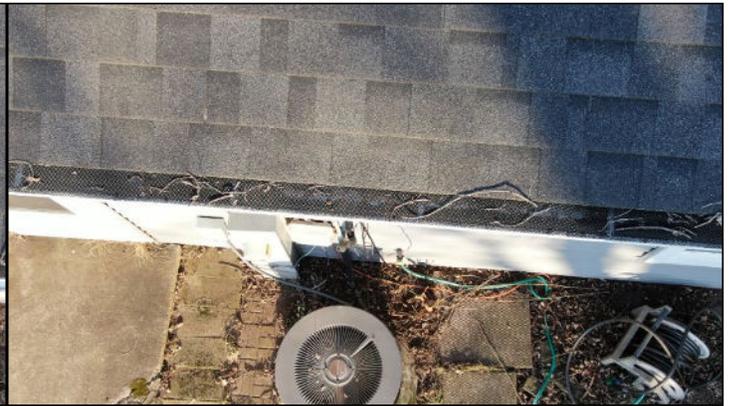
Gutters need to be cleaned.

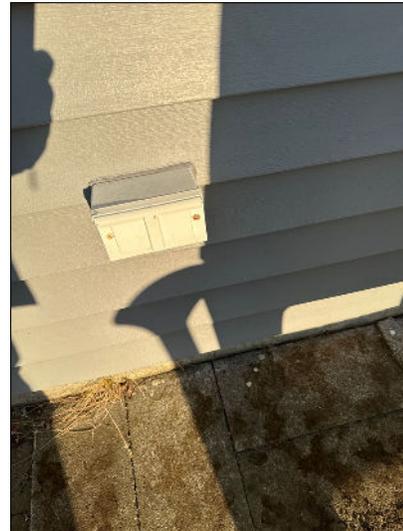
4.2. GFCI Outlet at - Rear did not trip when tested.

GFCI Outlet at - Rear did not trip when tested.

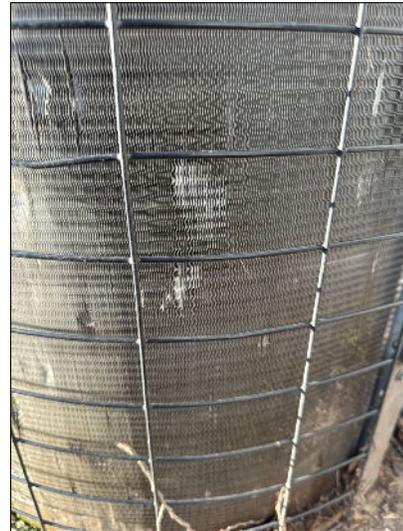
Dirty/Obstructed fins

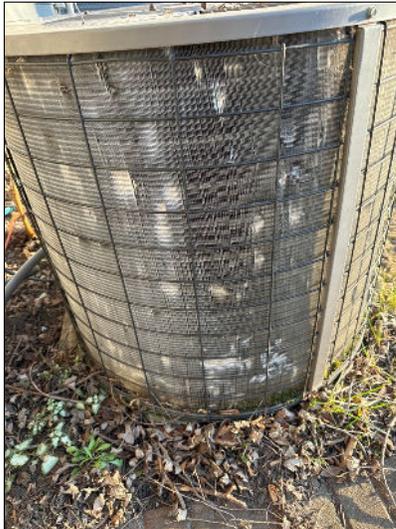
Dirty/Obstructed fins

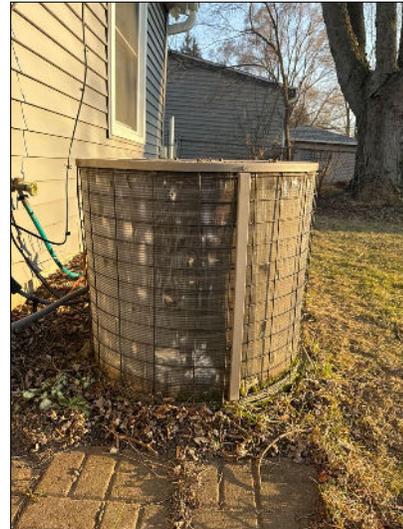
Exterior unit not level. This can affect system performance.

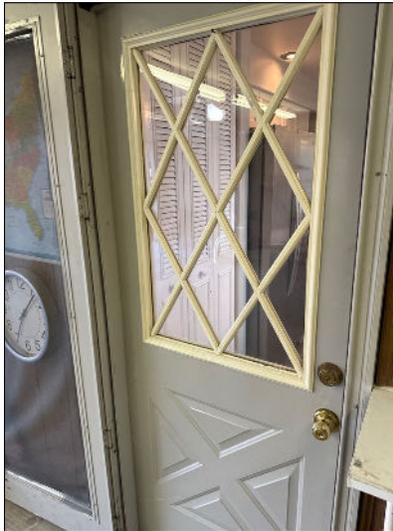
- 5.1. The door from the house, leading to the garage (man door), does not close automatically. It is strongly recommended that this door self-close to act as a fire stop and keep exhaust fumes out of the house.
- 5.2. The door between the garage & house does not appear to be a fire rated door. This may not have been required when originally built. Fire doors are fundamental to the integrity of fire barriers which provide resistance to the spread of fire, smoke, and toxic gasses.

Door does not appear to be fire rated.

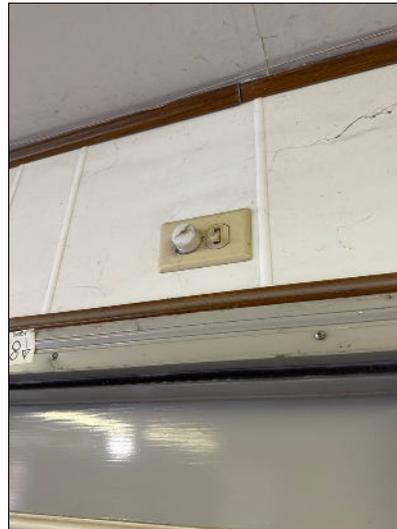
Switch(es) have unknown function, consult the seller for clarification on what they control.

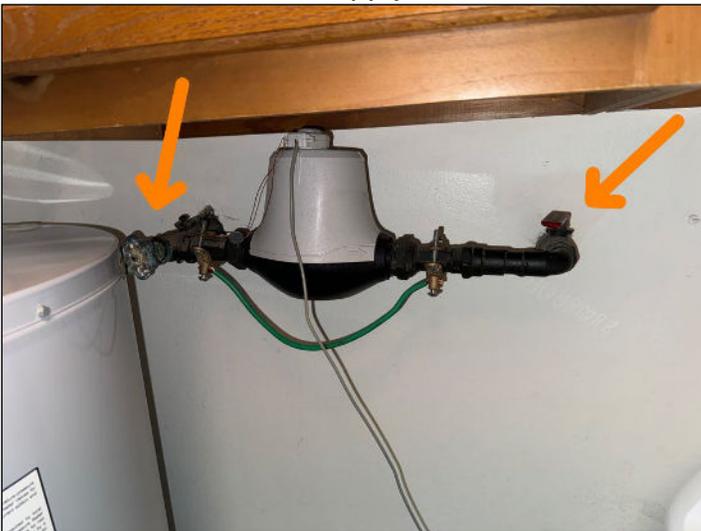
Water main shut off

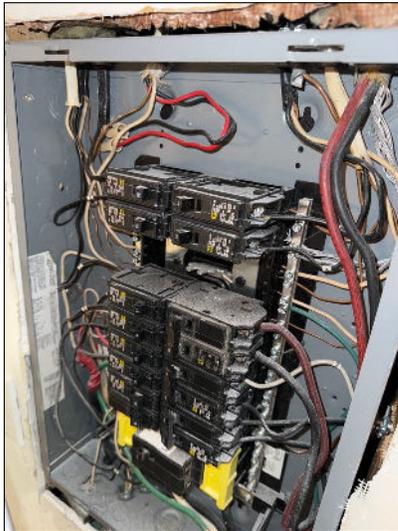
1.4. The space around the Electrical Service Equipment does not allow for safe access. Working space shall be provided and maintained about all electrical equipment to permit ready and safe operation and maintenance of such equipment.

A 3 ft wide x 3ft deep area is required in front of electric panels.

Main electrical panel

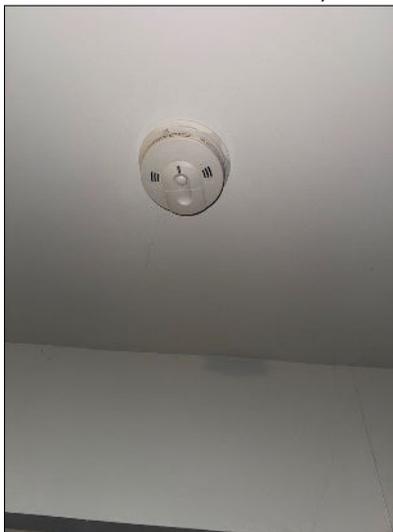
1.1. Smoke Detector on the Main Floor was Combination -Smoke/CO Detector present during the inspection. NOTE: Smoke detectors should be replaced every 10 years from the date of manufacturing (the date should be indicated on the device).

Combo - Smoke/CO Detector

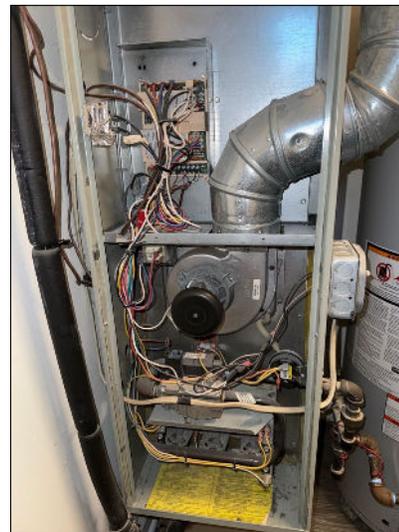
Opened all readily operable access panels

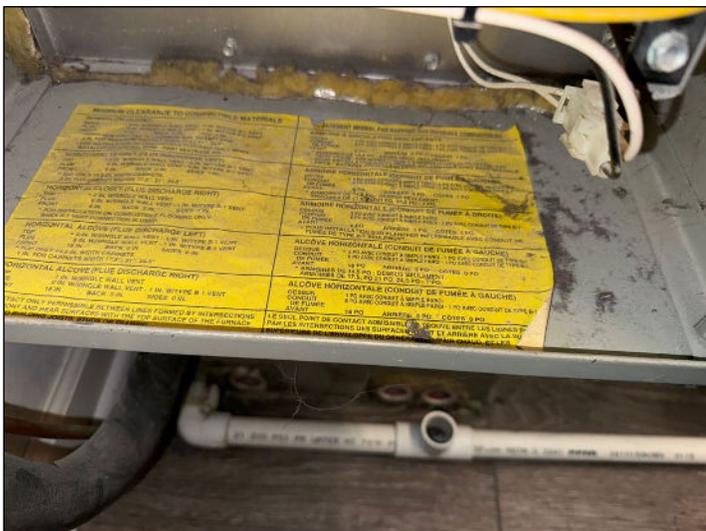
Dirt/dust buildup

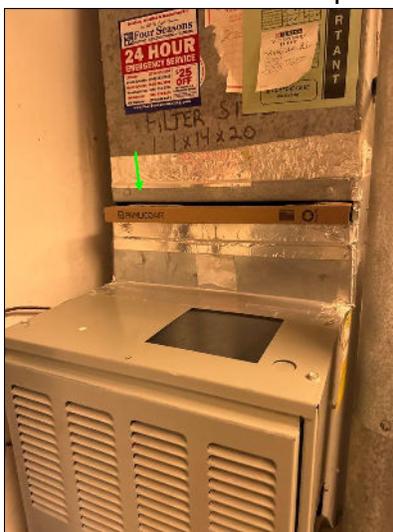
- 5.1. The furnace filter appeared functional at the time of inspection

Air Filter

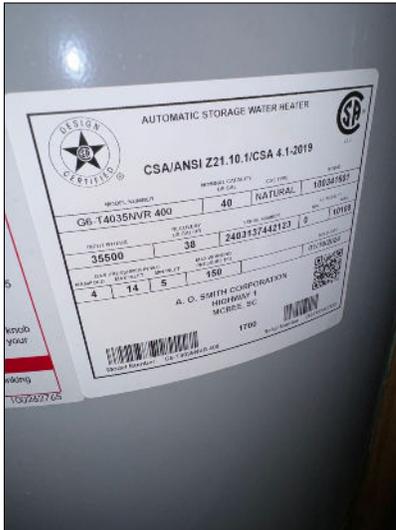
Water Heater Data Plate

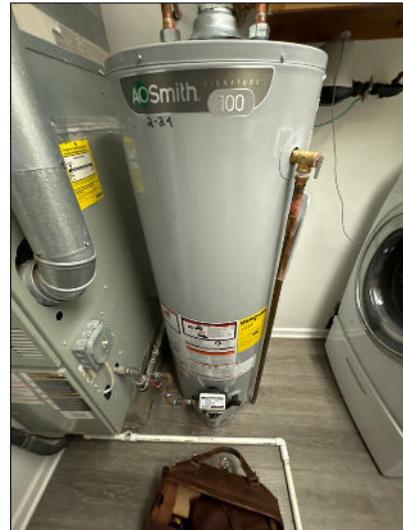
1.1. Water heater tank appears to be in satisfactory condition.

Water Heater

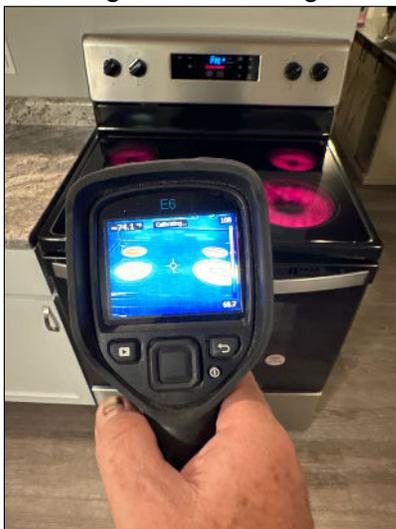
Operated when tested

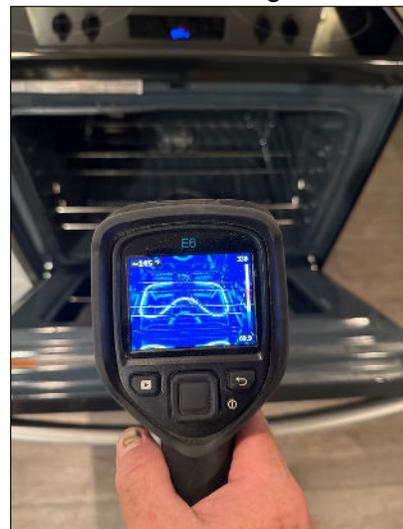
Operated when tested

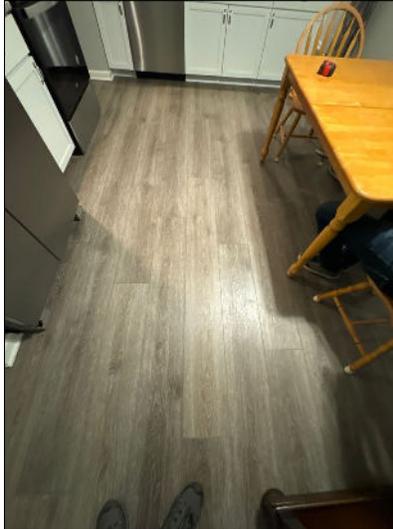
No deficiencies observed

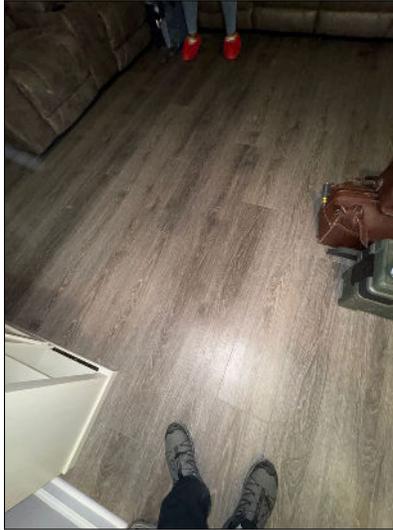
No deficiencies observed

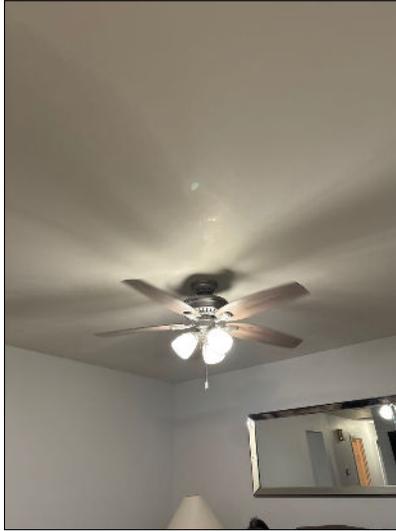
Operated

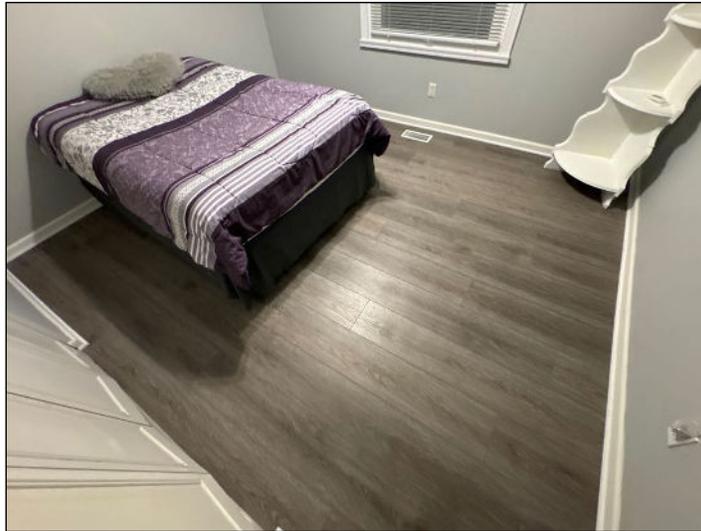
No deficiencies observed

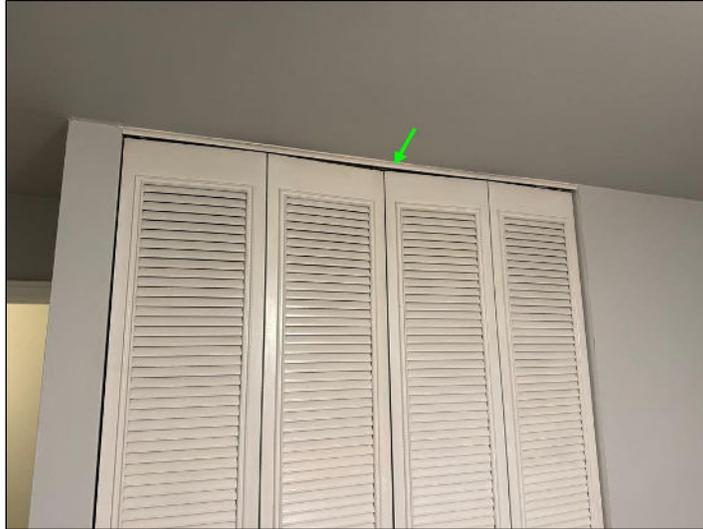
The closet door binds or drags.

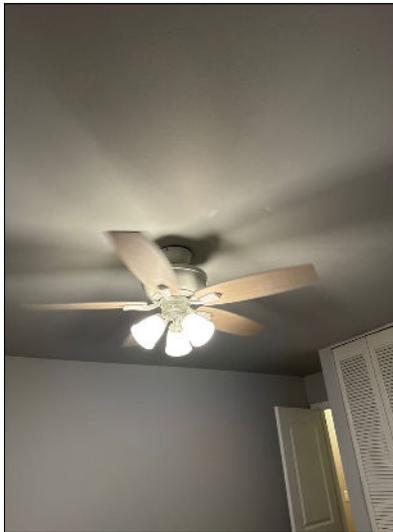
Operated

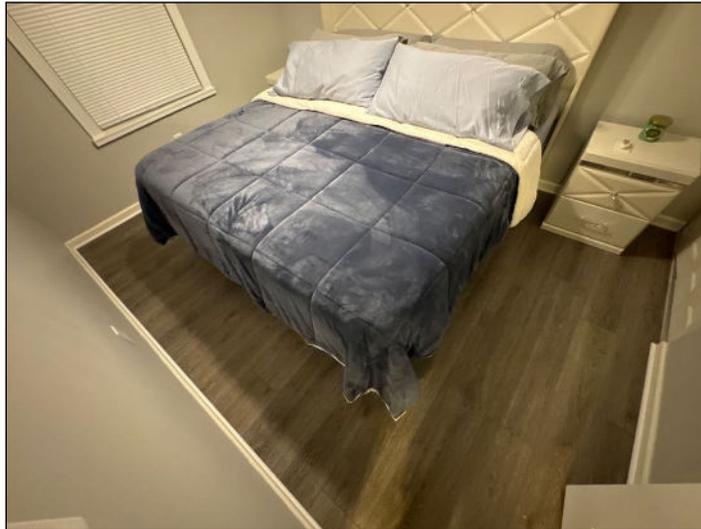
No deficiencies observed

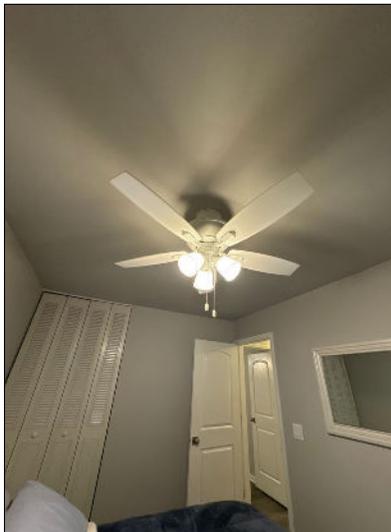
Operated

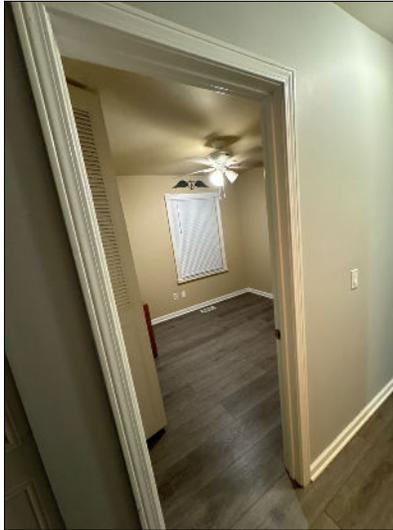
Door missing / NOT installed.

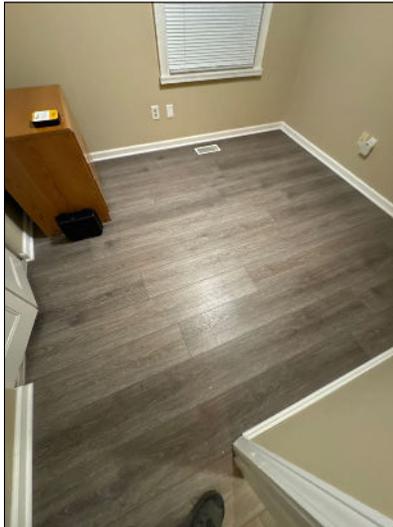
No deficiencies observed

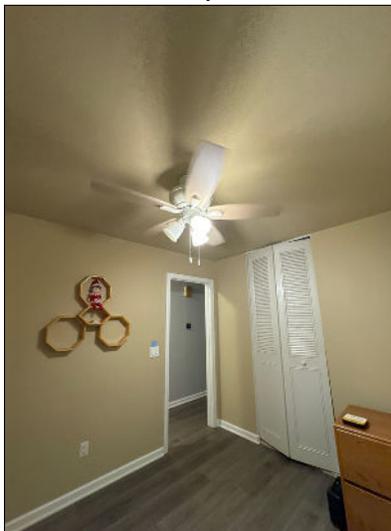
Operated

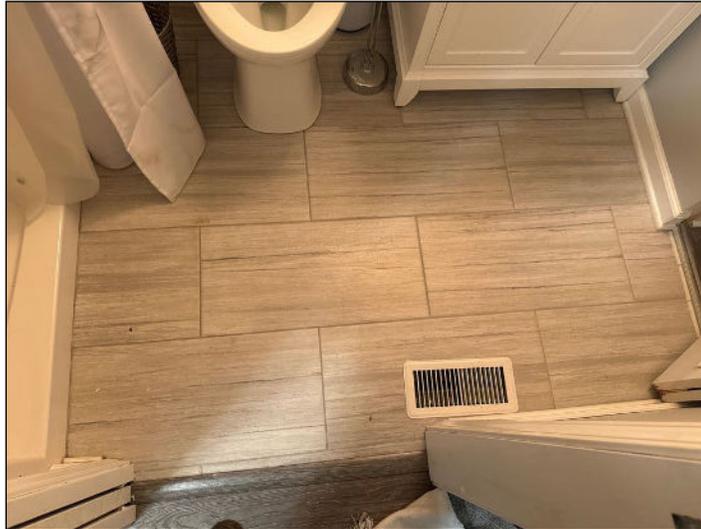
No deficiencies observed

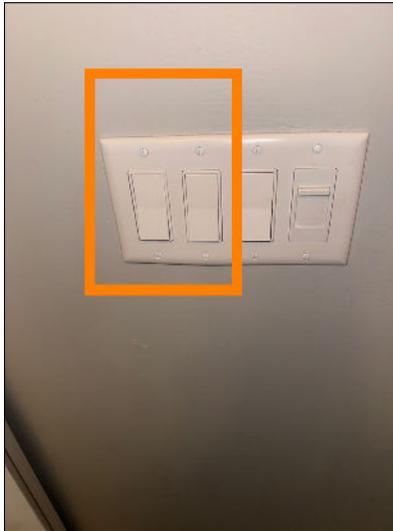
Switch(es) have unknown function, consult the seller for clarification on what they control.

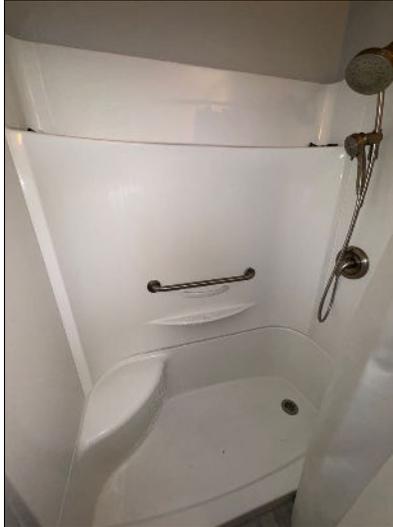
No deficiencies observed

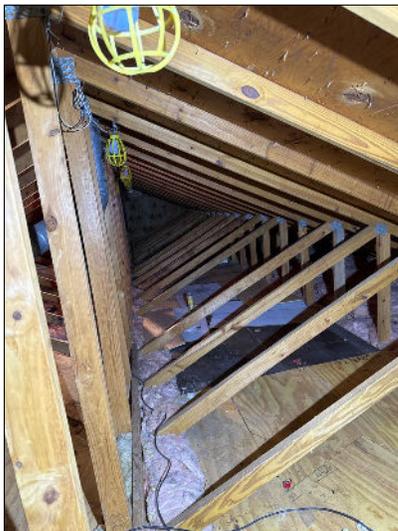
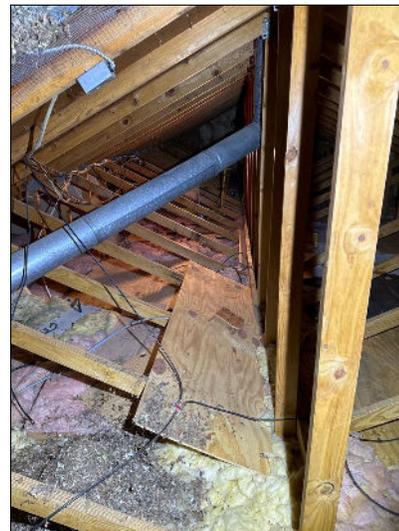
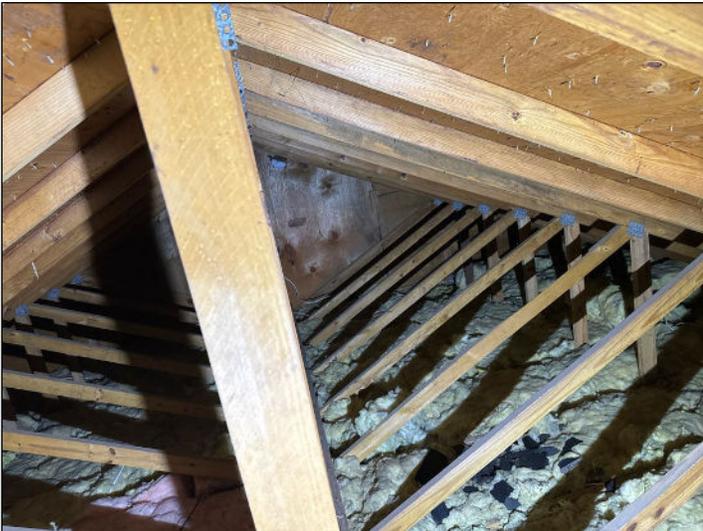
Attic Structure

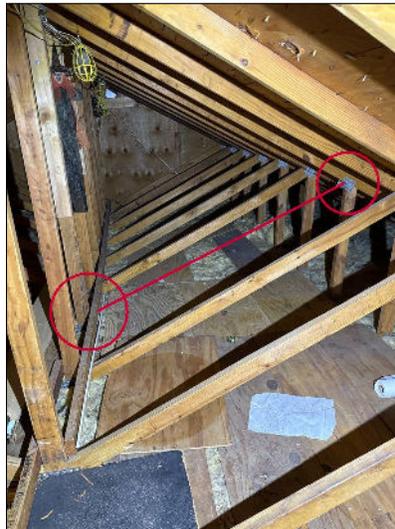
2.5. 2 truss cross members have been removed. This can affect the structural integrity of the attic structure. Recommend review by a qualified contractor.

2 truss cross members have been removed. This can affect the structural integrity of the attic structure. Recommend review by a qualified contractor.

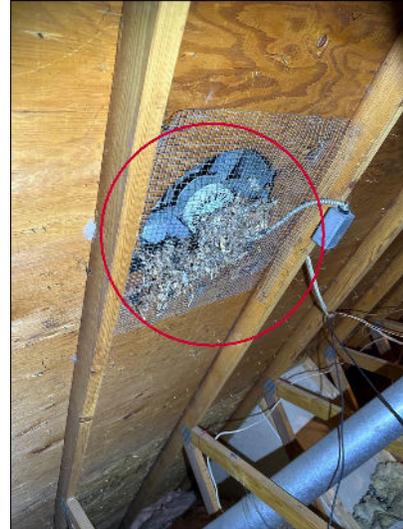
There is evidence of vermin activity. A pest control specialist should be consulted for treatment and control advice.

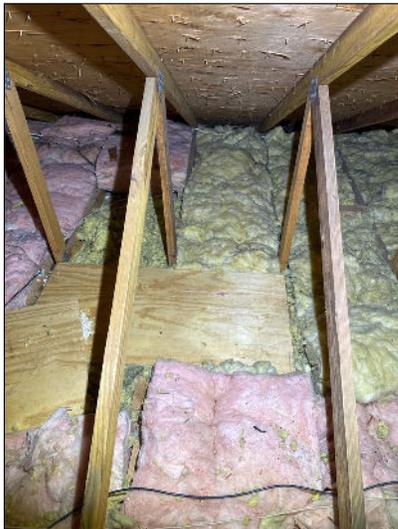
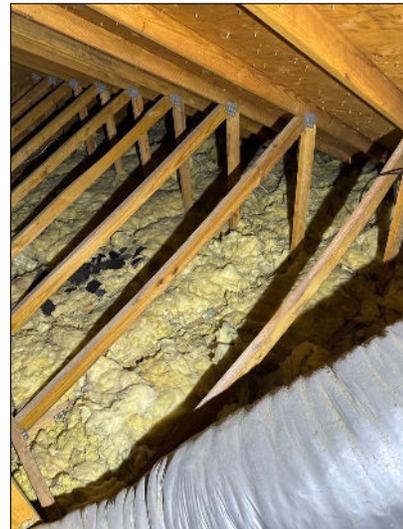
Insulation

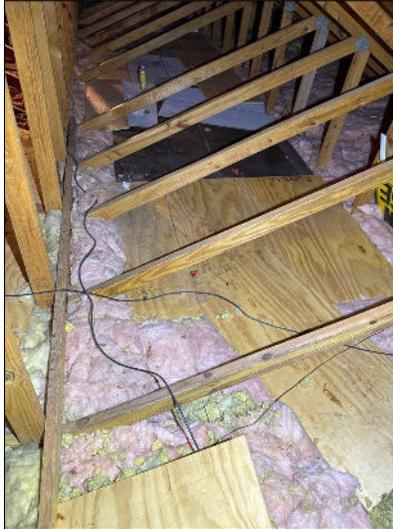
Depth: Insulation averages about 4-6 inches in depth; more recommended.

5.1. Insulation level is lower than current standards. Recommend adding more to conserve energy and make the building more comfortable.

Insulation

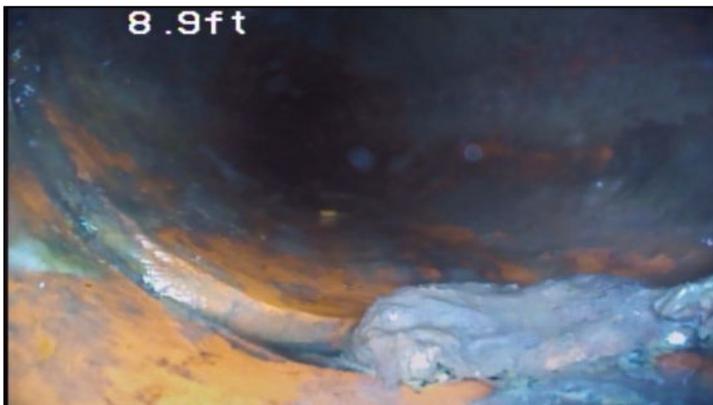
Deposits/Material buildup noted which are affecting the drainage flow.

3.3. Cast Iron Scale - sections of the pipe were noted to have scale build up inside the pipe. Recommend High pressure water jetting can remove some of the scale and provide temporary relief from drainage clogs and stoppages.

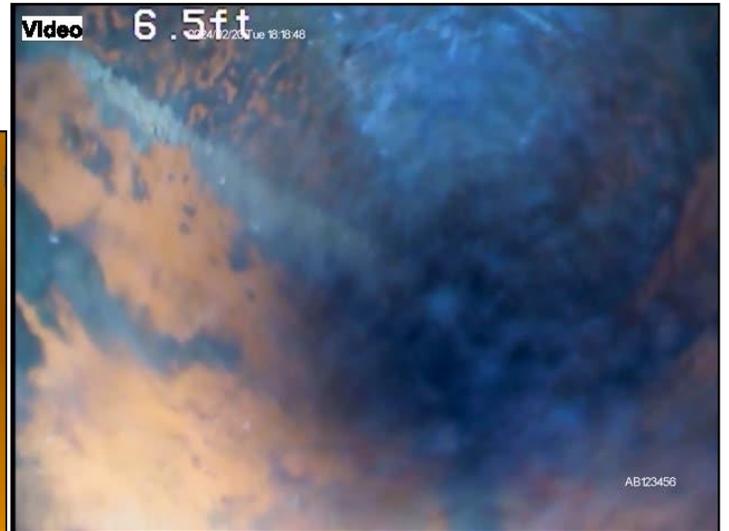
2.2. An obstruction was noted.

An obstruction was noted.

3.2. The obstruction needs to be removed to prevent blockage of wastewater through the pipe. Recommend evaluating the area(s) for repairs.
